Town of Windsor

TO: The Honorable Mayor and Town Council
FROM: William G. Saunders, IV, Town Manager
SUBJECT: Windsor Town Center Repairs

Re: Roof Survey, Roof Inspection, HVAC and Moisture Evaluations

WINDSOR TOWN CENTER VISUAL ROOF CONDITION ASSESSMENT

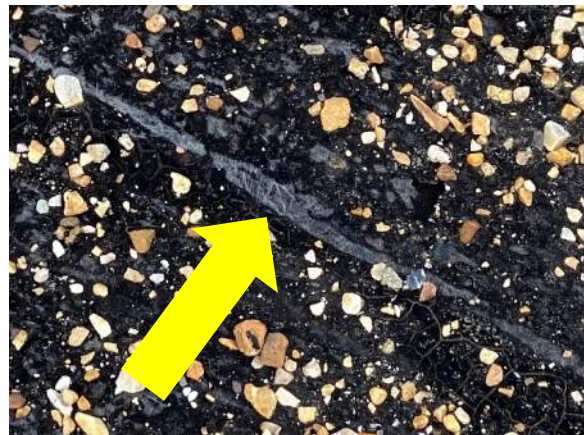
A Exposed ply sheet reinforcing scrim. Moisture wicked into the ply sheet causes further deterioration during freeze/thaw.

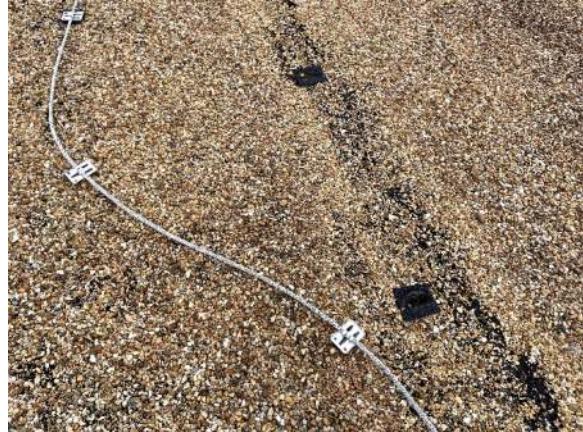
B Loose lightning cable on roof surface. The cable may damage the roof during wind events.

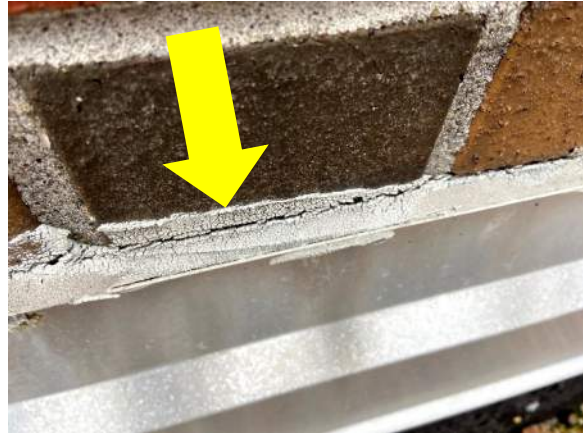
C Deteriorated/separated sealant in counterflashing sealant tray allows water to bypass the counterflashing exposing the top of the base flashing membrane beneath.

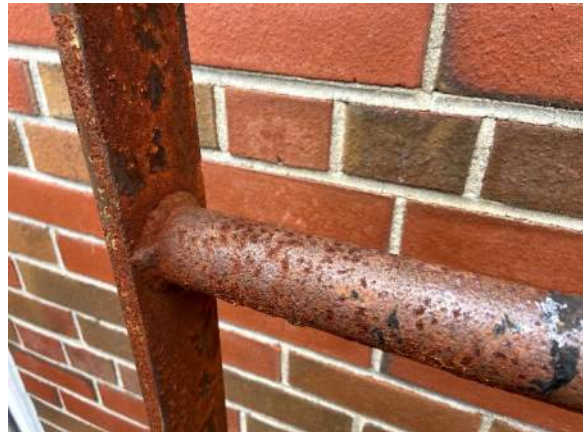
D Corroded steel wall mounted ladder. The ladder should be cleaned, primed, and painted during a future roof replacement project to prevent further corrosion.

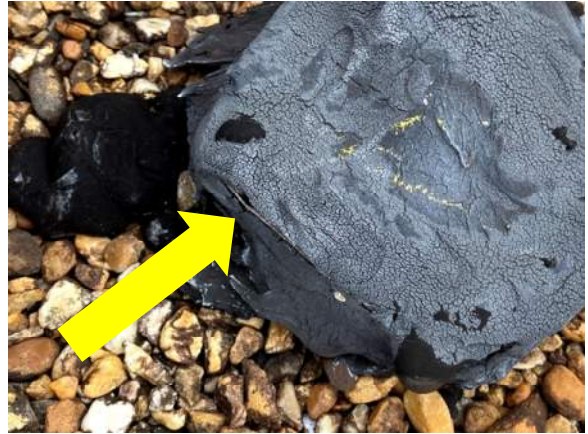
E Deteriorated and separated pitch pocket mastic. The separation between the pitch pocket and the mastic is a path for water infiltration.

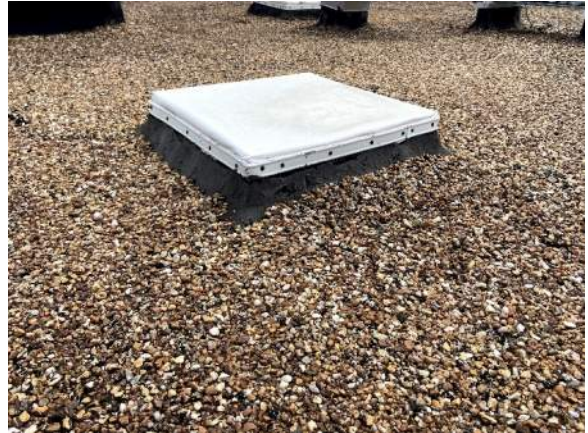
F Low flashing height on abandoned curbs. Roof industry standards require 8" minimum base flashing height to prevent water intrusion.

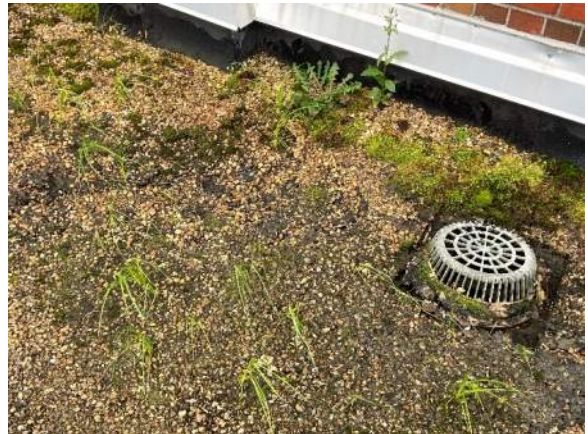
G Vegetation on roof surface indicating poor drainage. During a future roof replacement, provide tapered insulation to promote drainage.

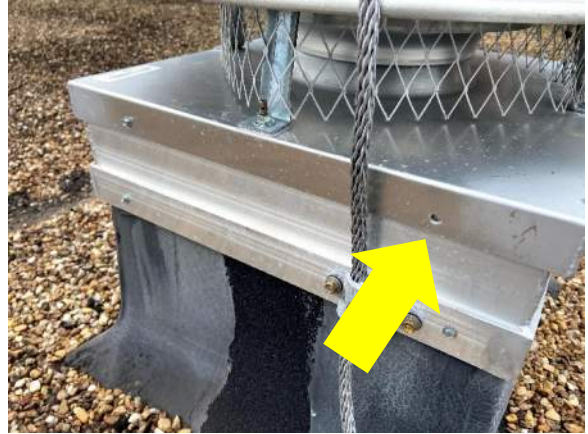
H Improperly fastened power vent. Install a new gasketed screw to prevent damage during wind events.

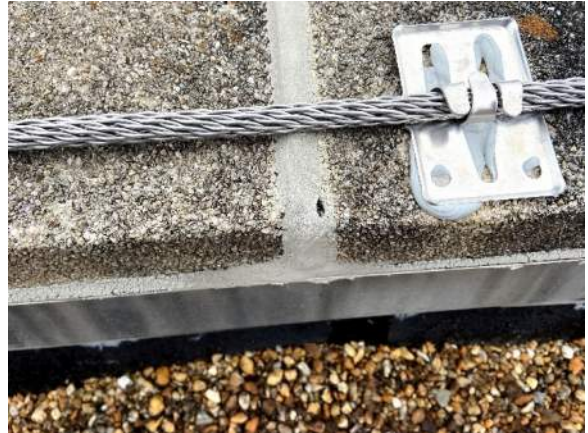
I Separated sealant at concrete coping joint is open to water infiltration.

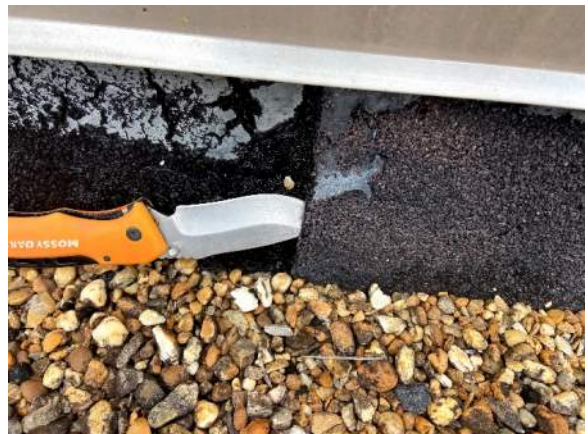
J Open base flashing laps open to water infiltration.

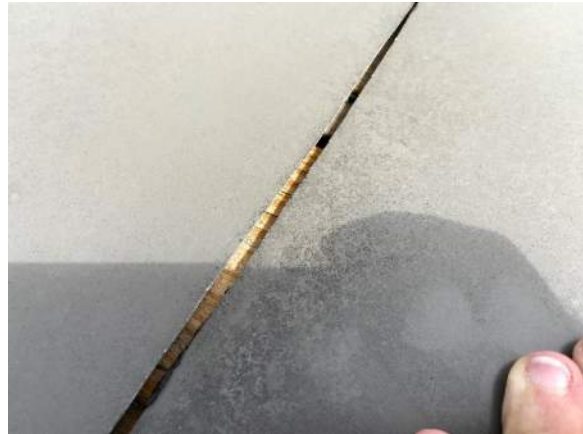
K The sealant in the metal coping laps are separated or missing. A membrane was not installed over the wood blocking beneath the metal coping. Install metal back up plates and sealant at each coping lap and a new roof membrane beneath the coping during a future roof replacement project.

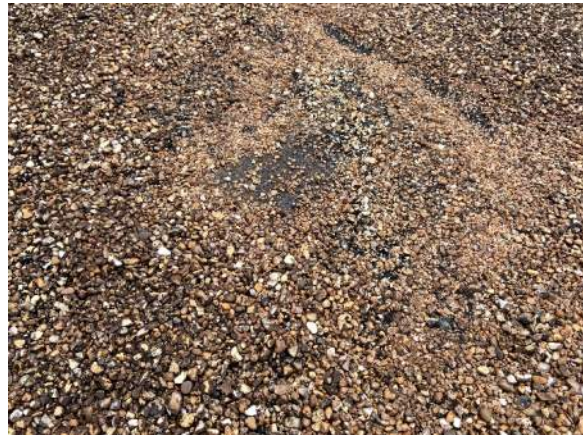
L Interply Blister in the roof surface.

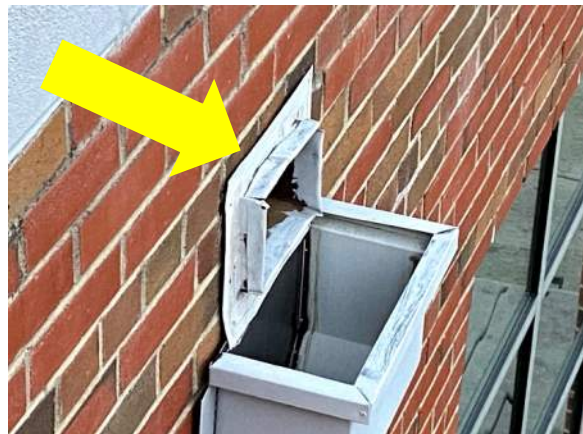
M Missing sealant at through wall scupper picture frame to brick cladding interface allows water infiltration into the wall and roof systems. Provide new through wall scupper sleeves and picture frames during a future roof replacement project.

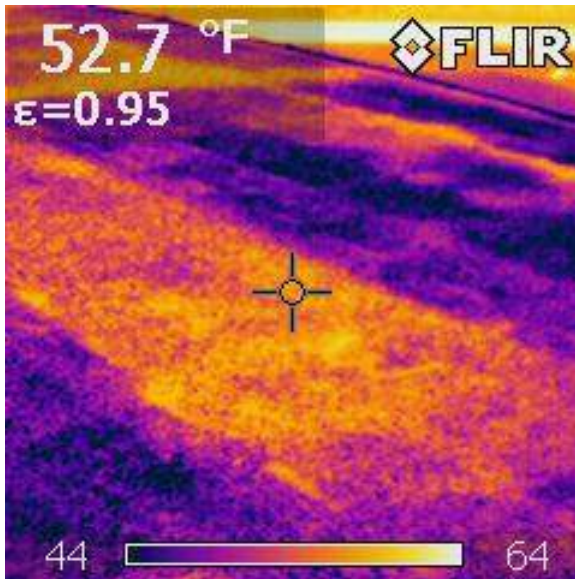
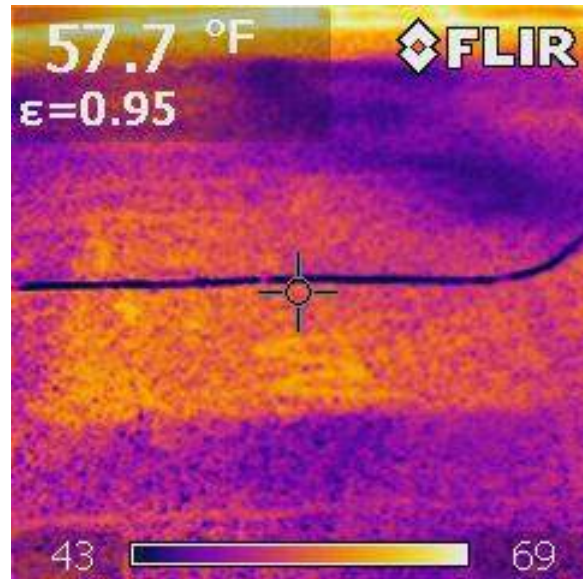
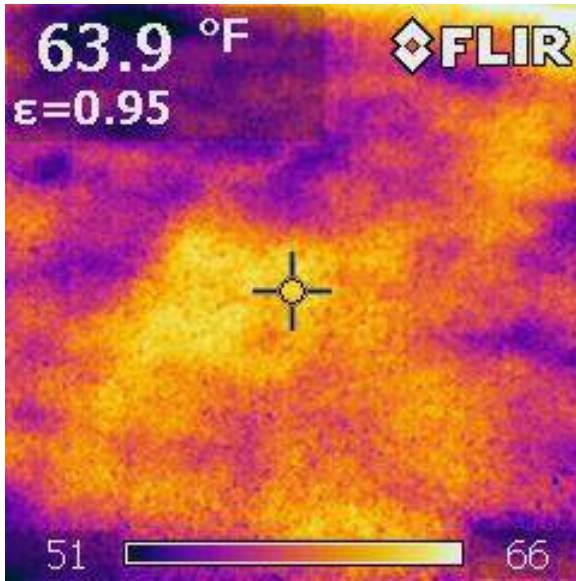
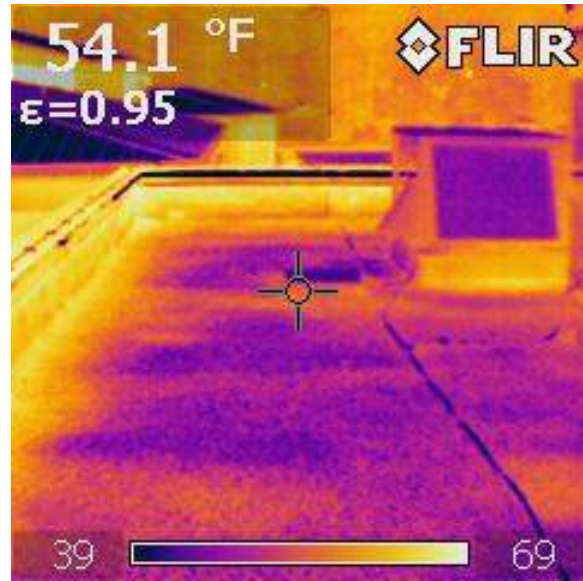
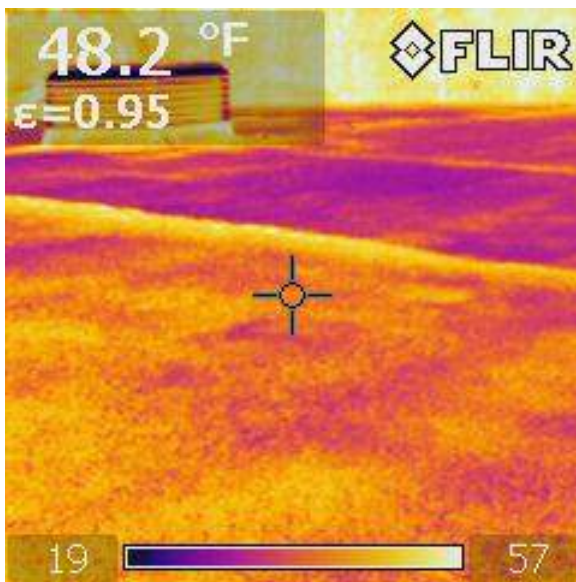
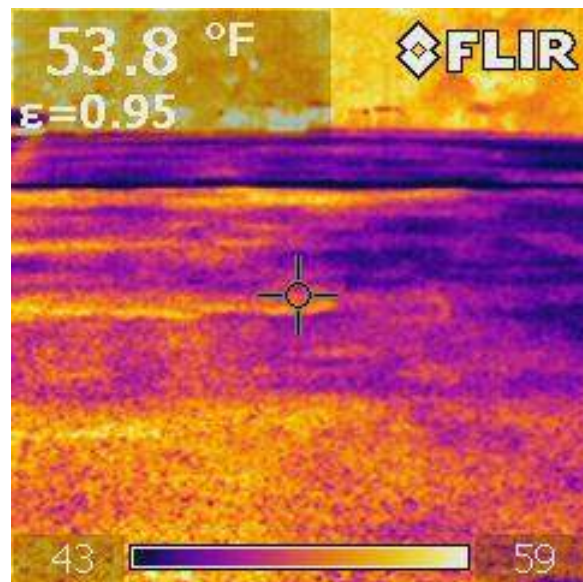
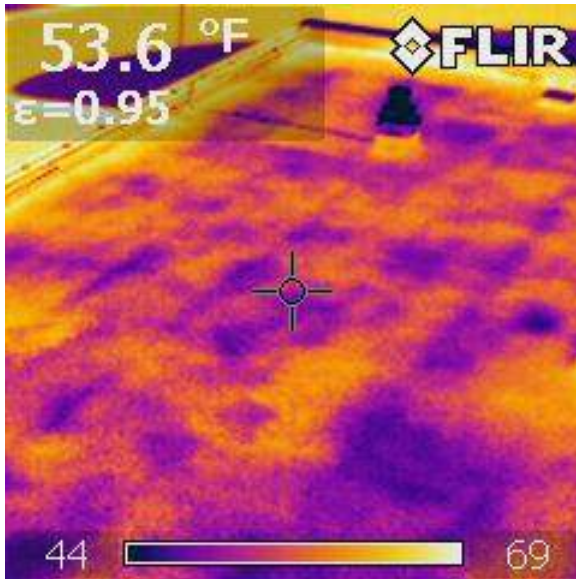
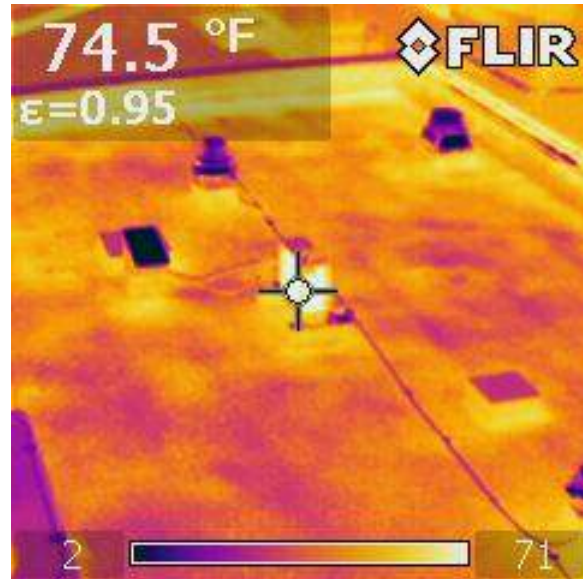
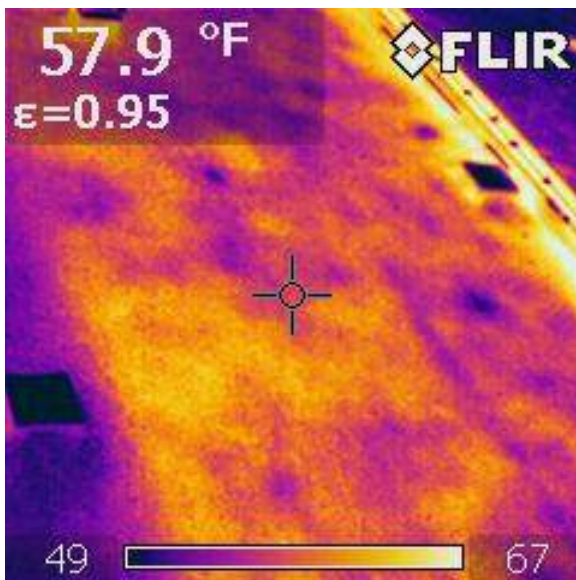
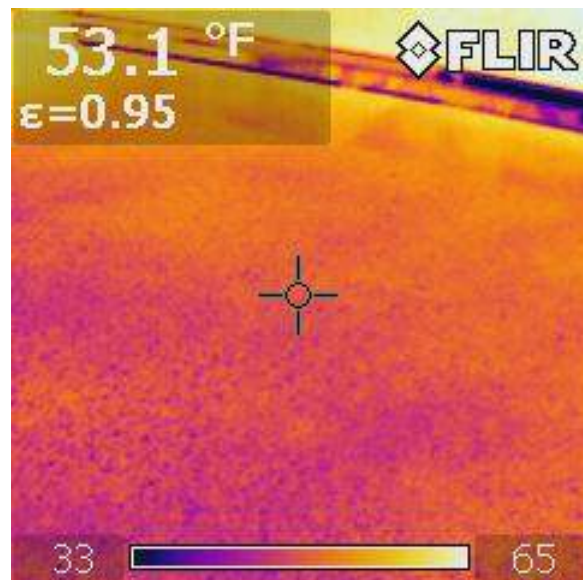
There was approximately 2,000 square feet of suspected wet insulation detected by the survey. The locations of these areas are shown on the attached roof plan. The suspected wet insulation locations were verified with Tramex RWS roof and wall scanner capacitance meter.

Based on our observations made during our visual assessment, the assumed age of the existing roof system, the amount of thermal anomalies present, and our experience with similar projects, we recommend completely removing the existing roof system down to the existing steel deck. The repair areas on the gymnasium were swept clean of the existing loose gravel surfacing allowing observations of the built up plys. The ply reinforcing scrim is indicative of an asphalt built up roof system at the end of its service life. Although the surface of the plys on the lower roof section is not observable, it is likely that the plys are experiencing the same deterioration.

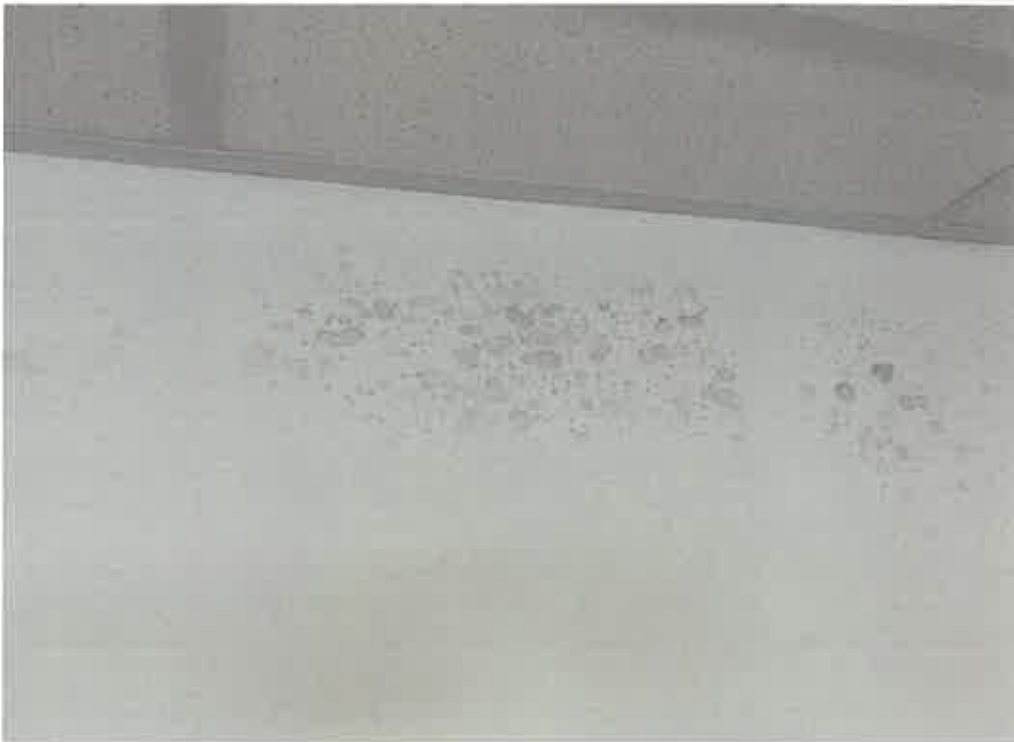
Photo 2: Meeting Room - Visible mold on the wallboard in the air flow path of the diffuses

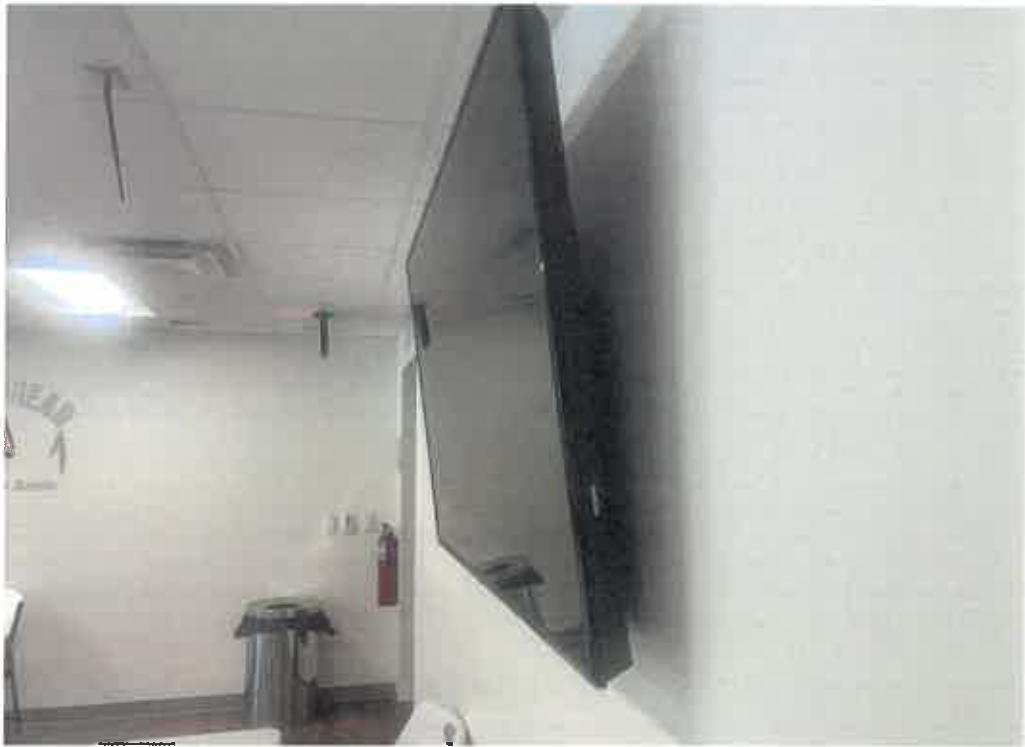
Photo 3: Photo 5: Visible mold on the wallboard behind the TV in the meeting room

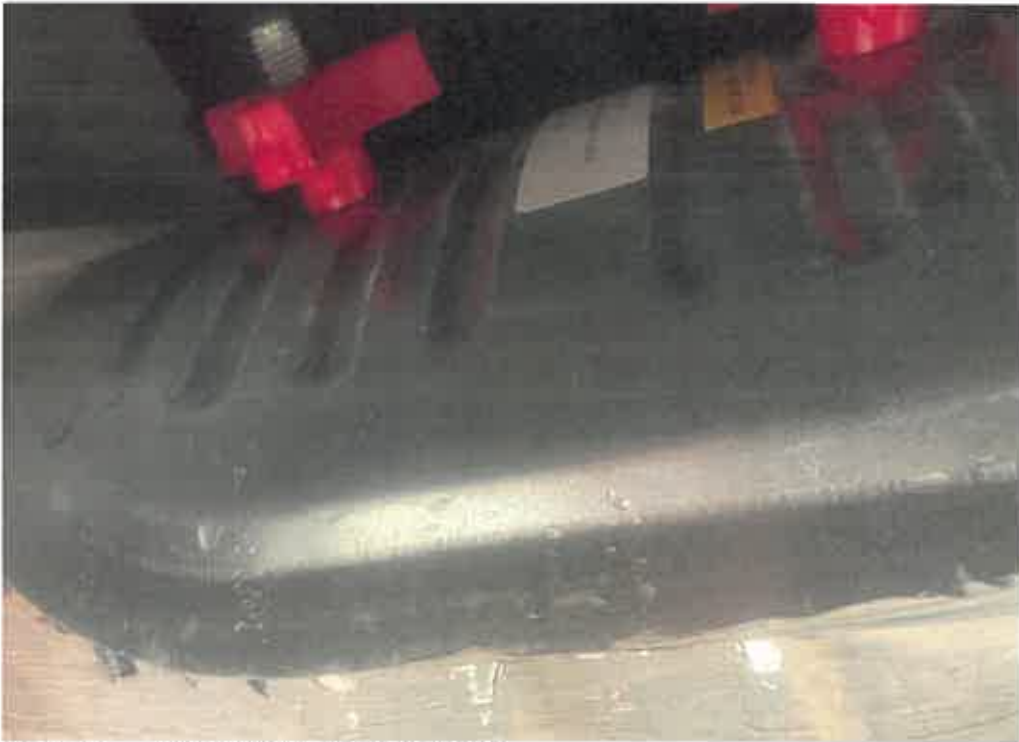
Photo 4: Condensation on the metal ductwork access doors

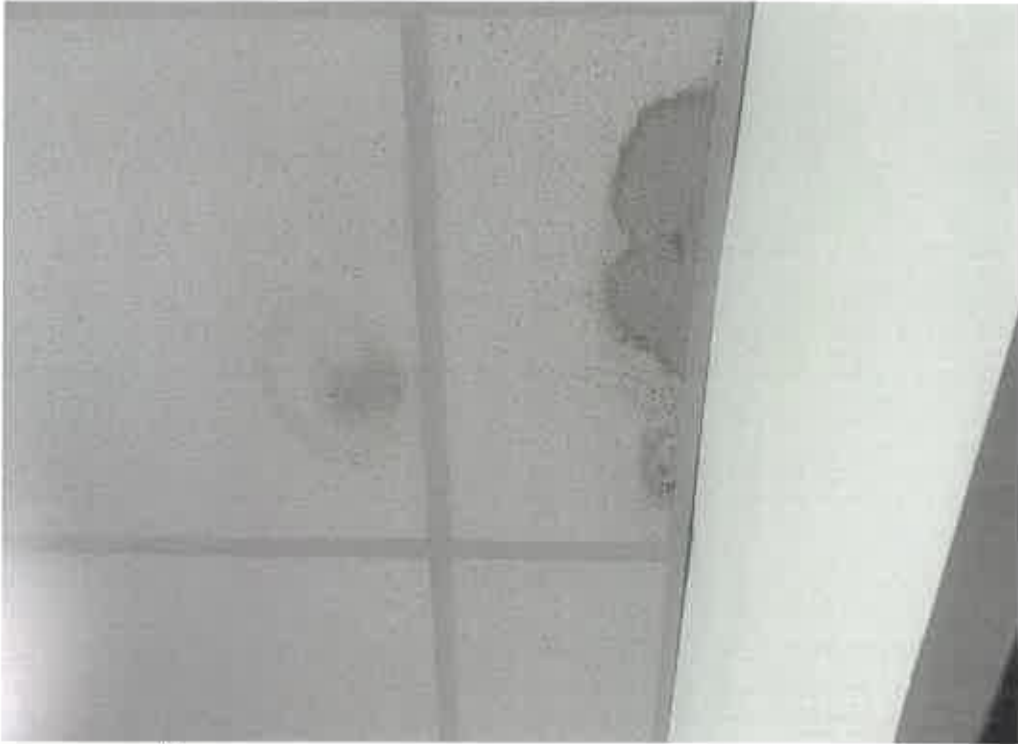
Photo 5: Various stained tile throughout

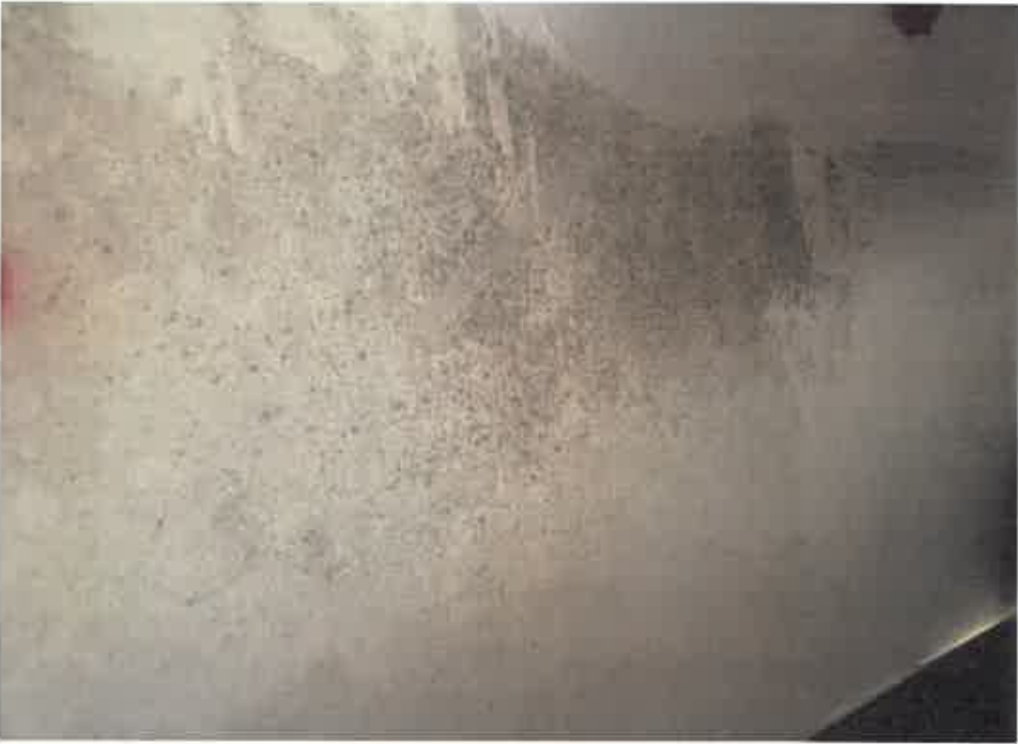
Photo 6: Visible mold on the wallboard above the suspected ceiling in the office

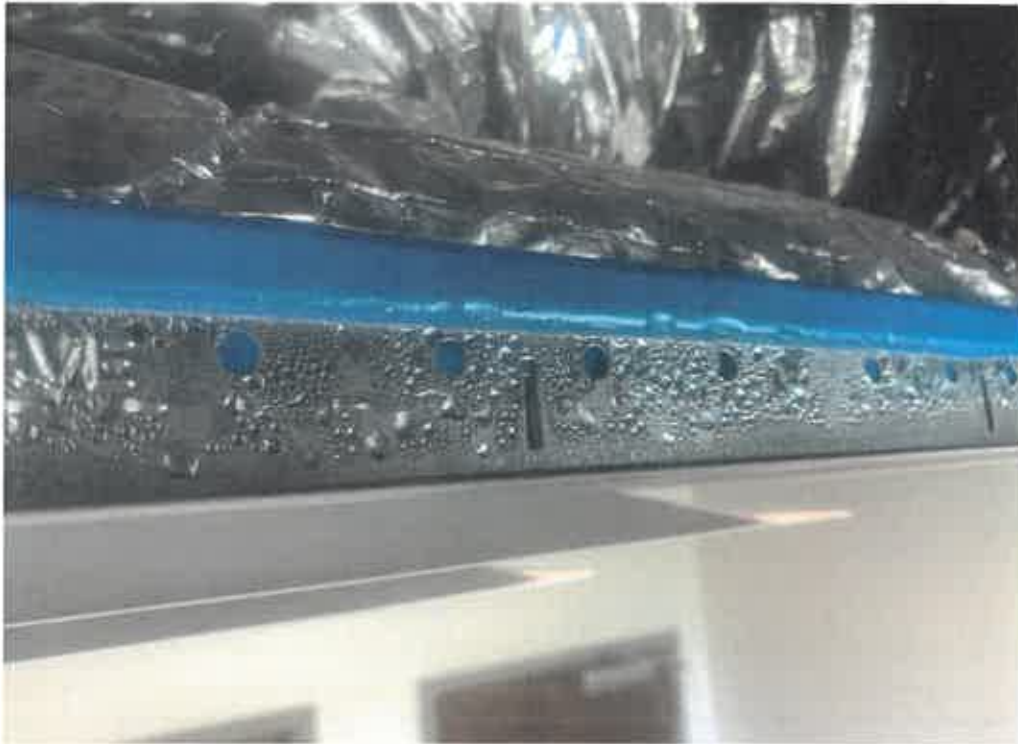
Photo 7: Condensation on the ceiling track near the diffusers

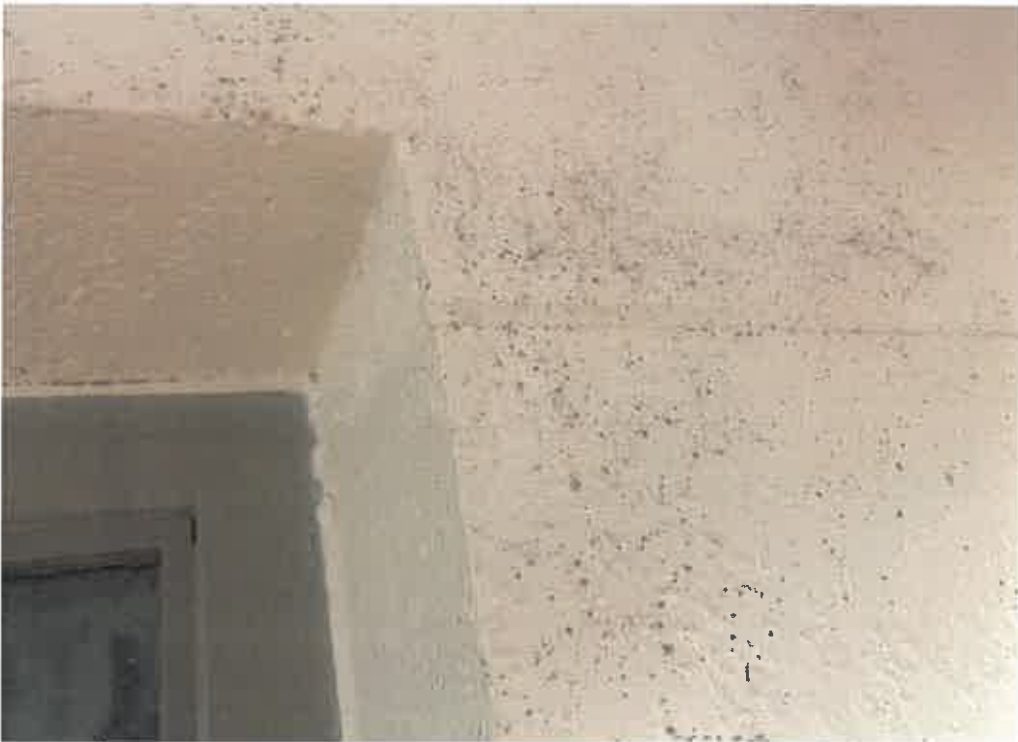
Photo 8: Visible mold on the CMU in the lounge area

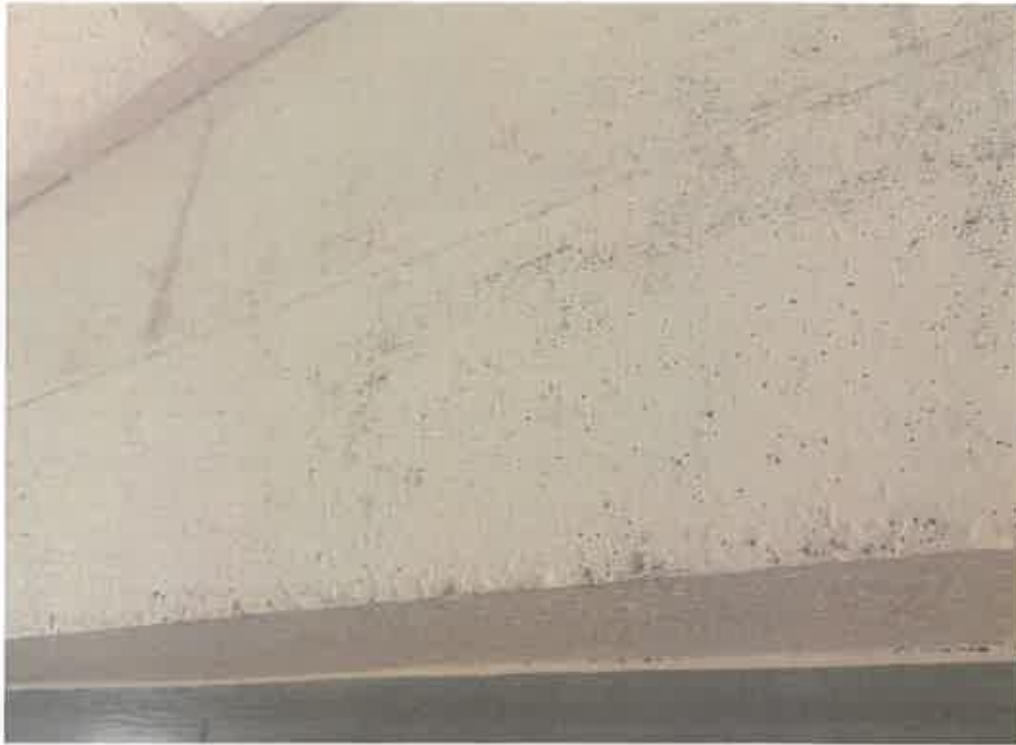
Photo 9: Visible mold on CMU in the lounge area

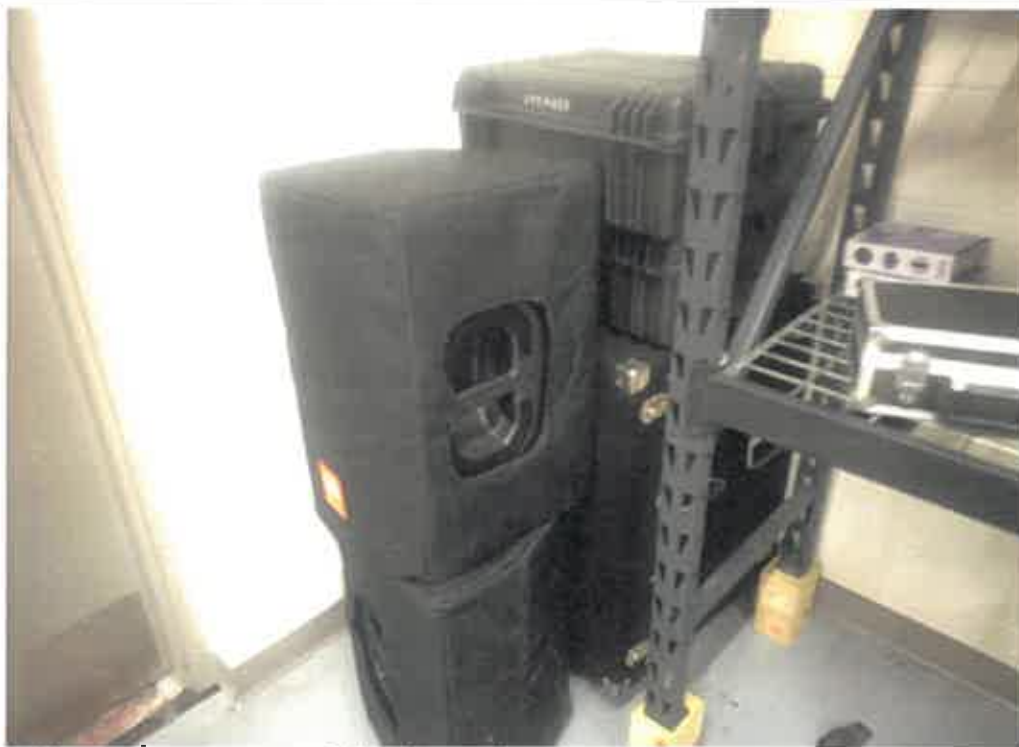
Photo 10: Visible mold on the canvas cases in the storage closet

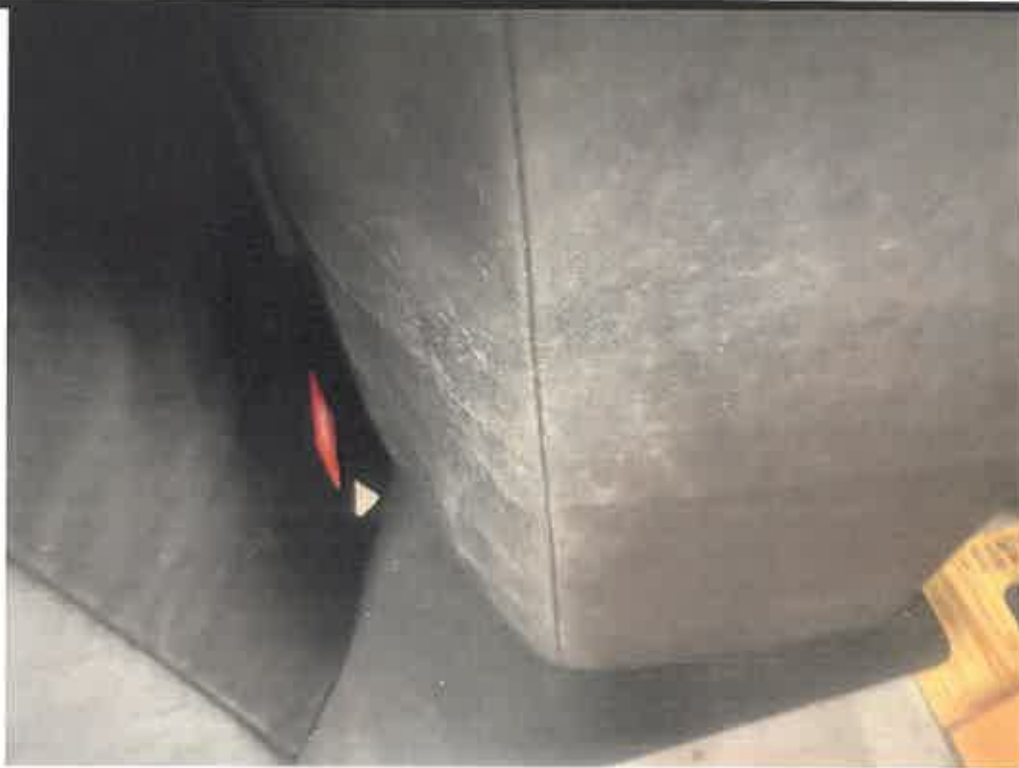
Photo 11: Visible mold on the canvas cases

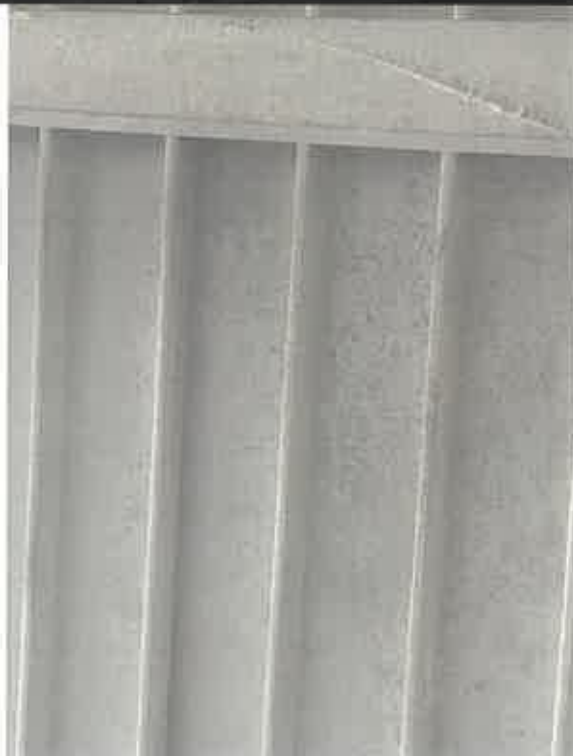
- Suspect mold was observed on the bottom of the roof deck. The height of the roof deck limited our inspection of this area.

Photo 12: Suspect mold on the bottom of the roof deck in the at room

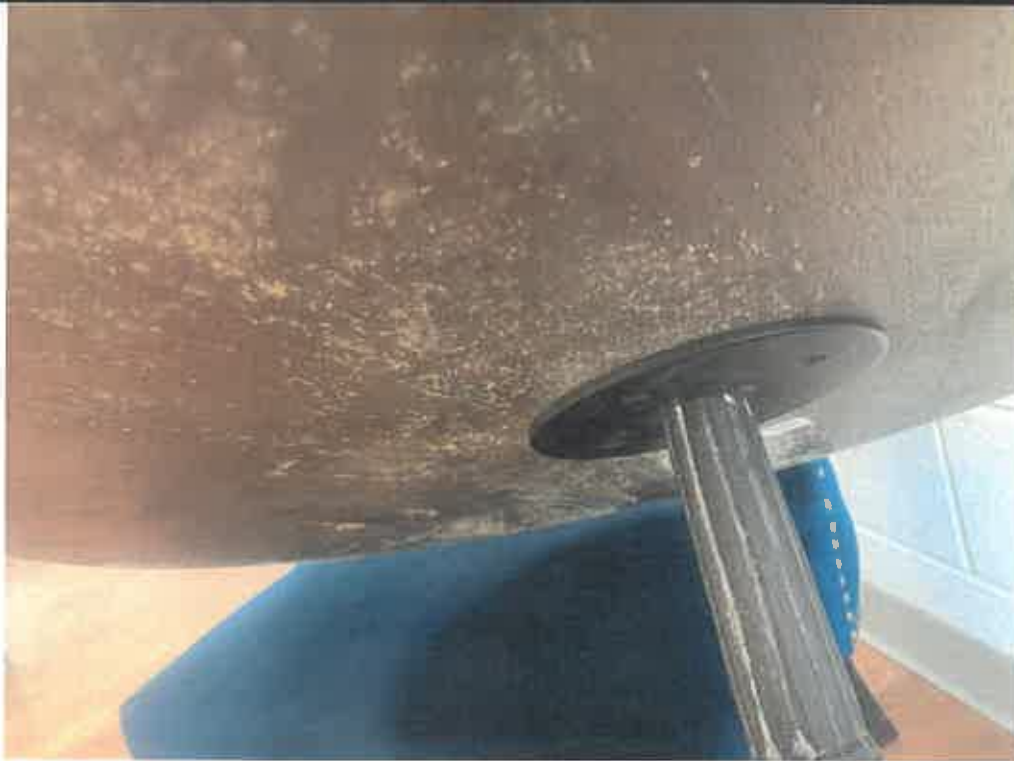
Photo 13: Visible mold on the bottom side of the table in the lounge area
