Roof System Condition Evaluation Report

Facility Name: Georgie D. Tyler Middle School
 101 Georgie D. Tyler Drive
 Windsor, VA

Roof Inspection Summary

Inspection Date: 04/17/2012

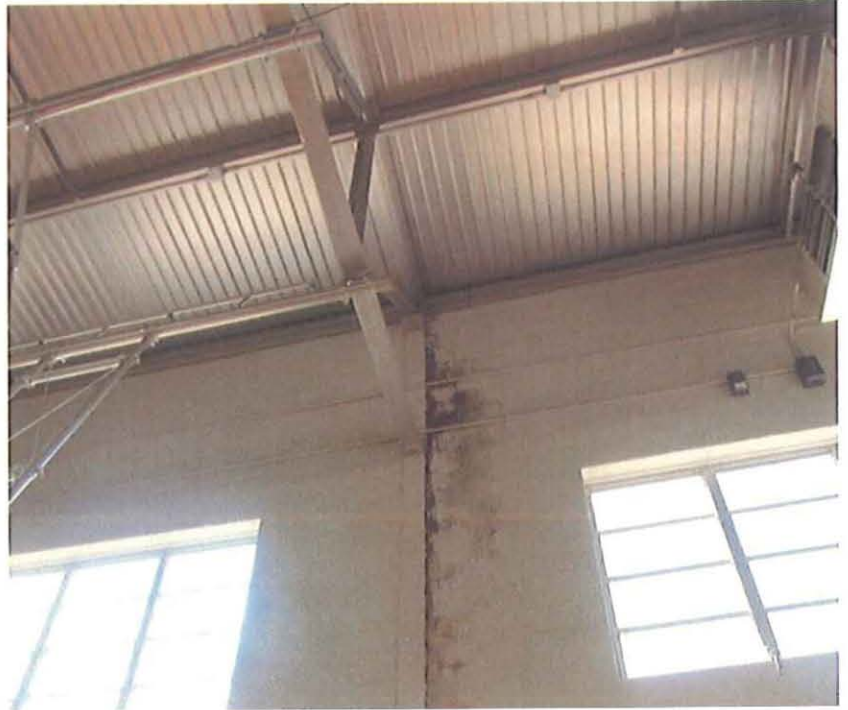
3. Water stains on wall

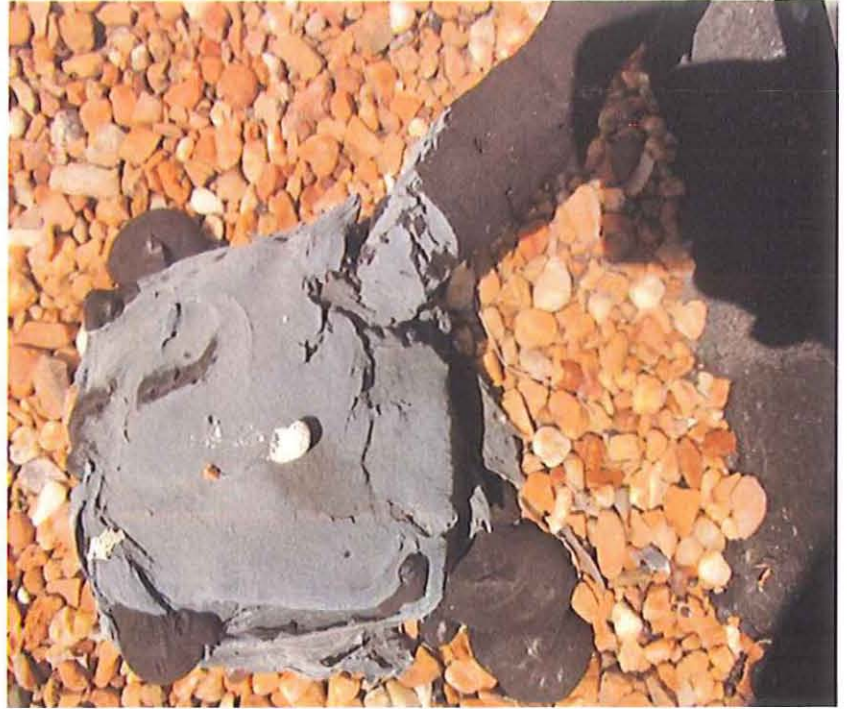
7. Deficiency #1 - Open fill material
at pitch pocket

NUMBER	PRIORITY CODE	DEFICIENCY DESCRIPTION	QUANTITY	UNIT PRICE	REPAIR COST
		DEFICIENCY SOLUTION	UNITS		
1	M	Low / open fill material at pitch pocket	1	\$50.00	\$50.00
		Remove loose / cracked sealant from pitch pocket	Each		
		Fill with compatible material to provide a convex finish to shed water away from the penetration			
2	M	Open coping joints	5	\$75.00	\$375.00
		Clean joint and seal with Sonneborn NP-1 or equal	Areas		
3	M	Deteriorated / missing caulk	7	\$50.00	\$350.00
		Remove loose / deteriorated caulk and seal with Sonneborn NP-1 or equal	Areas		
4	M	Open conditions at wall and curb base flashing laps	3	\$50.00	\$150.00
		Apply a five (5) course application of industrial grade roof cement and reinforcing fiberglass fabric over open base flashing laps to prevent moisture entry into the flashing and roof system	Each		
5	M	Disconnected downspout	3	\$50.00	\$150.00
		Re-connect downspout to restore positive drainage	Each

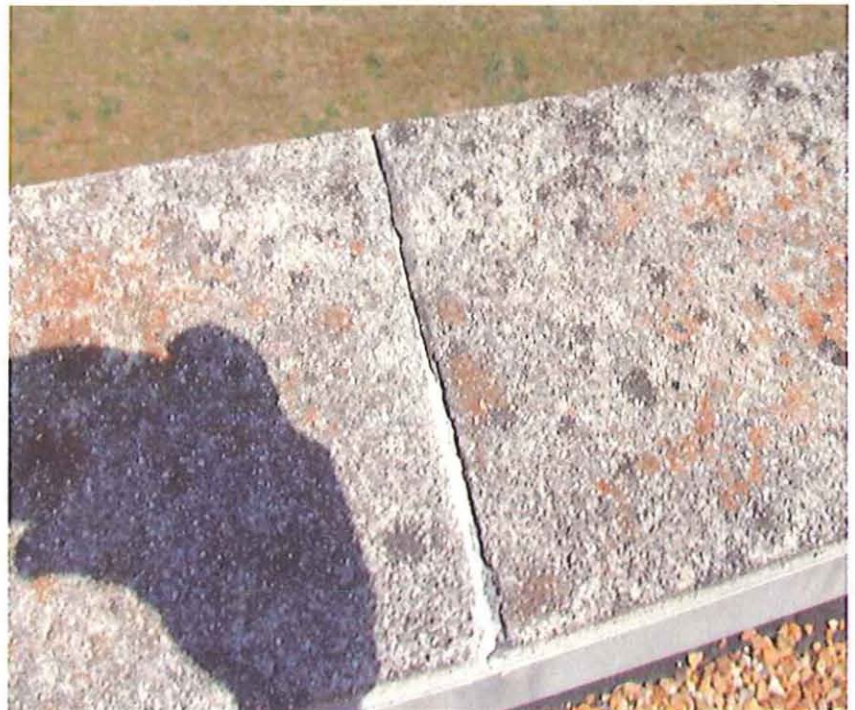
8. Deficiency #2 - Open coping joint

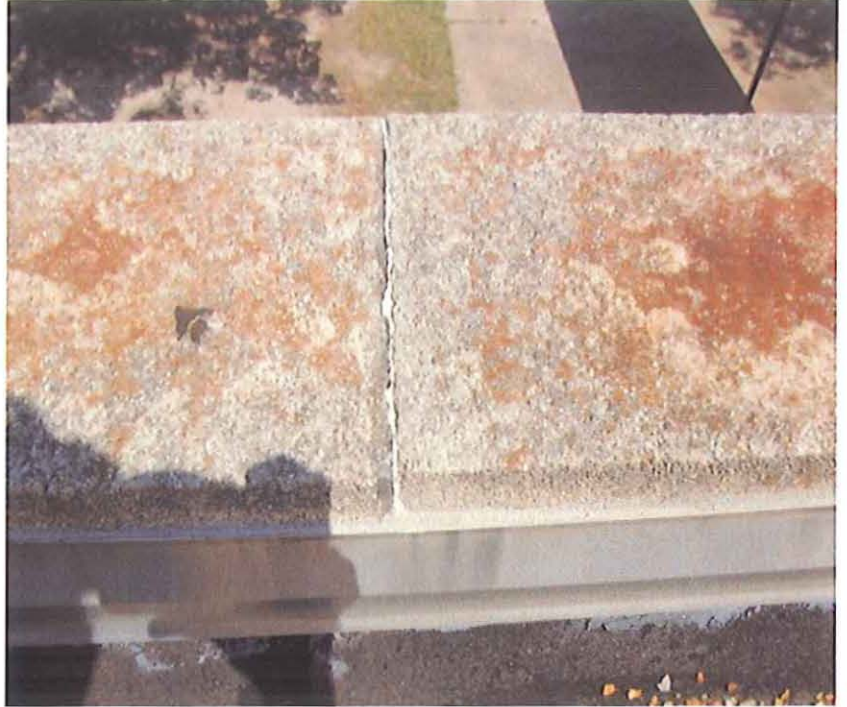
9. Deficiency #2 - Open coping joint

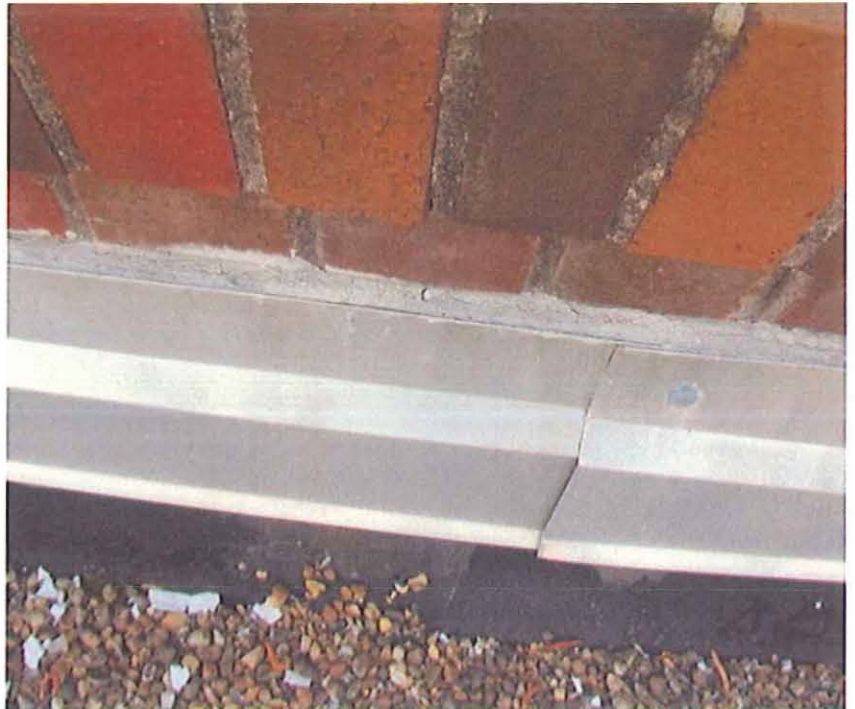
10. Deficiency #3 - Deteriorated caulk

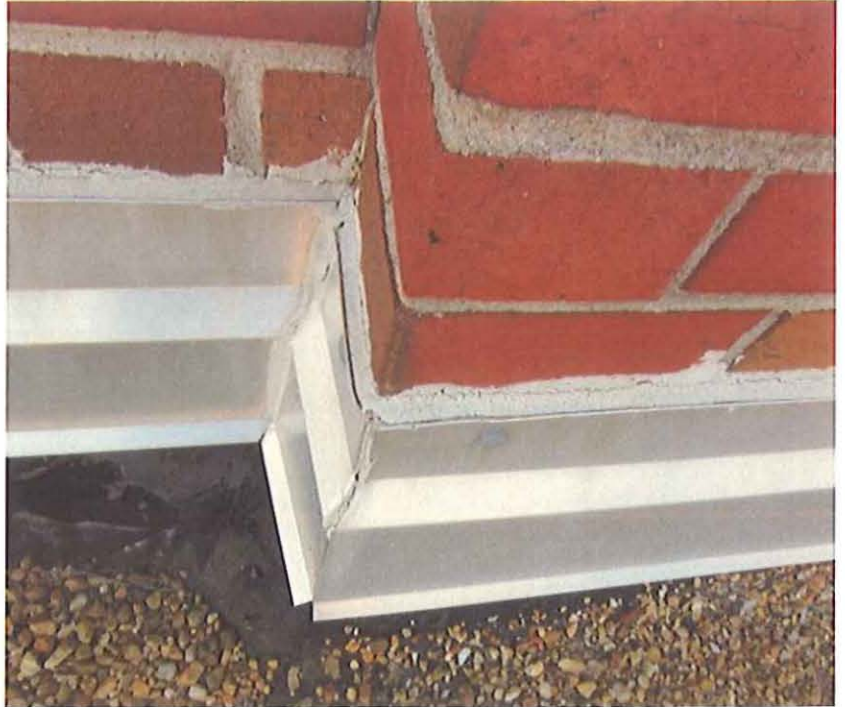
11. Deficiency #3 - Deteriorated
caulk

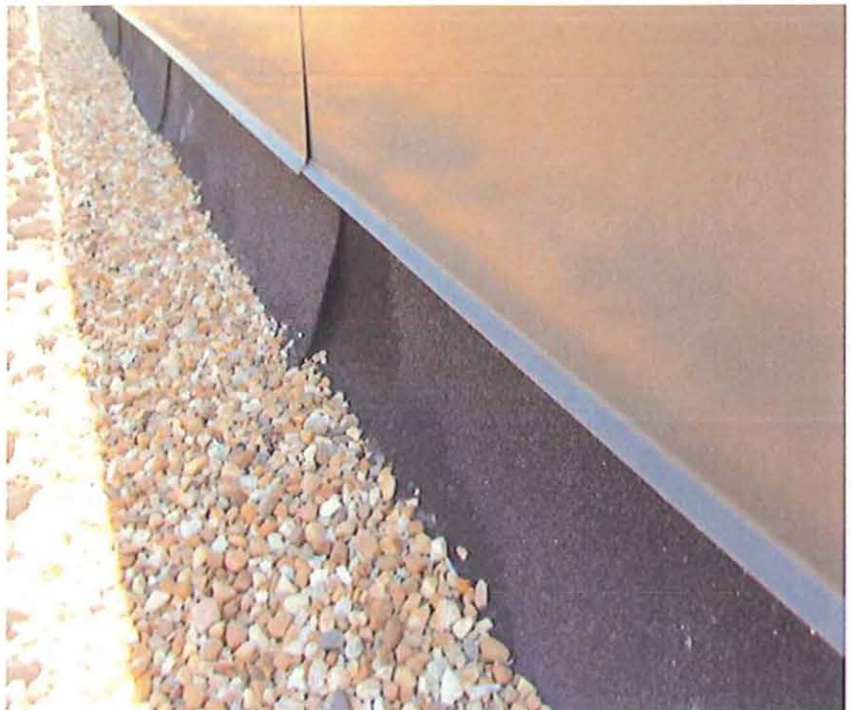
12. Deficiency #4 - Open condition
at wall flashing laps

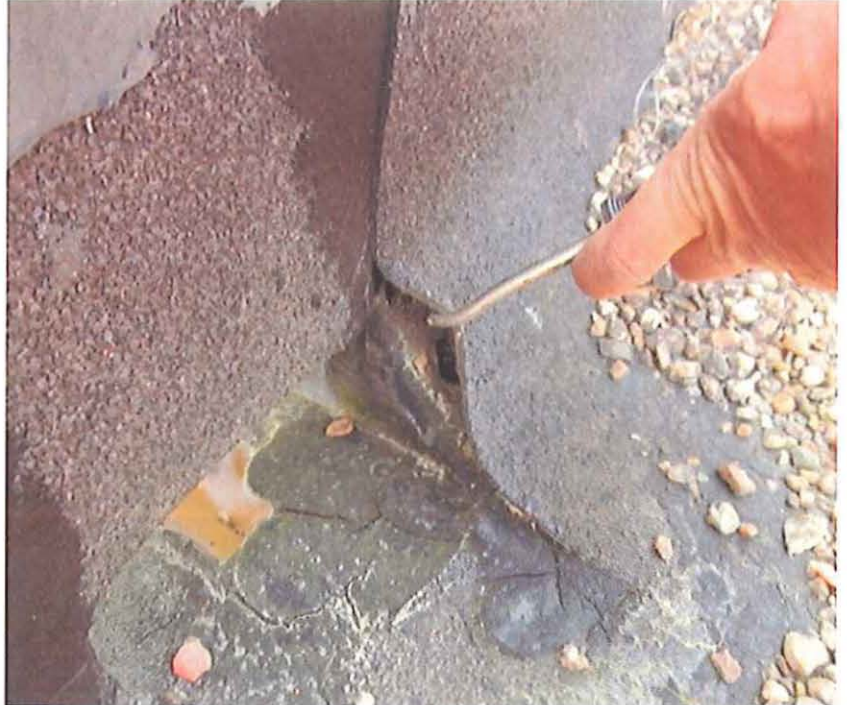
13. Deficiency #4 - Open condition
at wall flashing lap

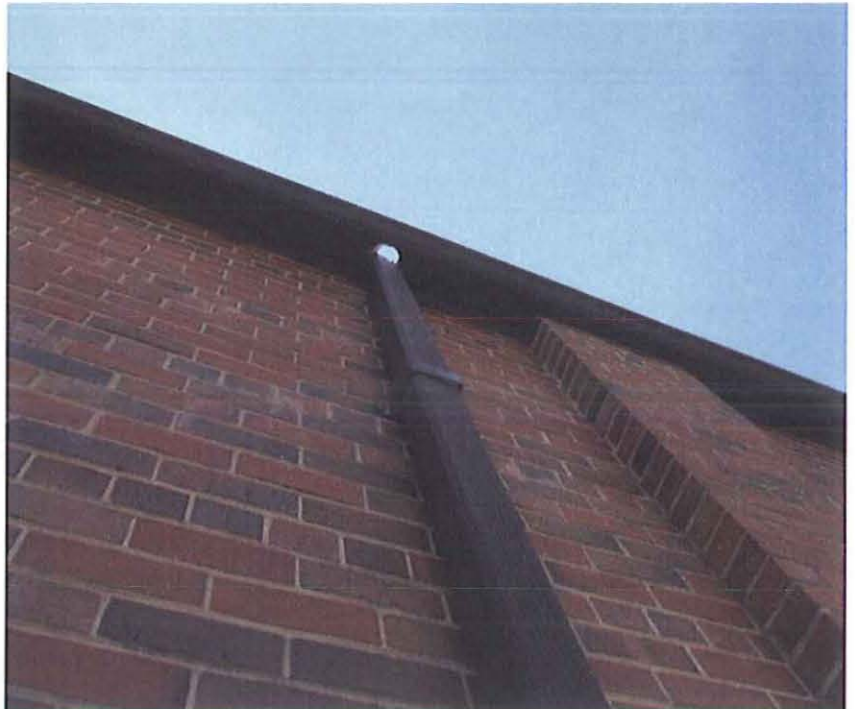
14. Deficiency #5 - Disconnected
downspout

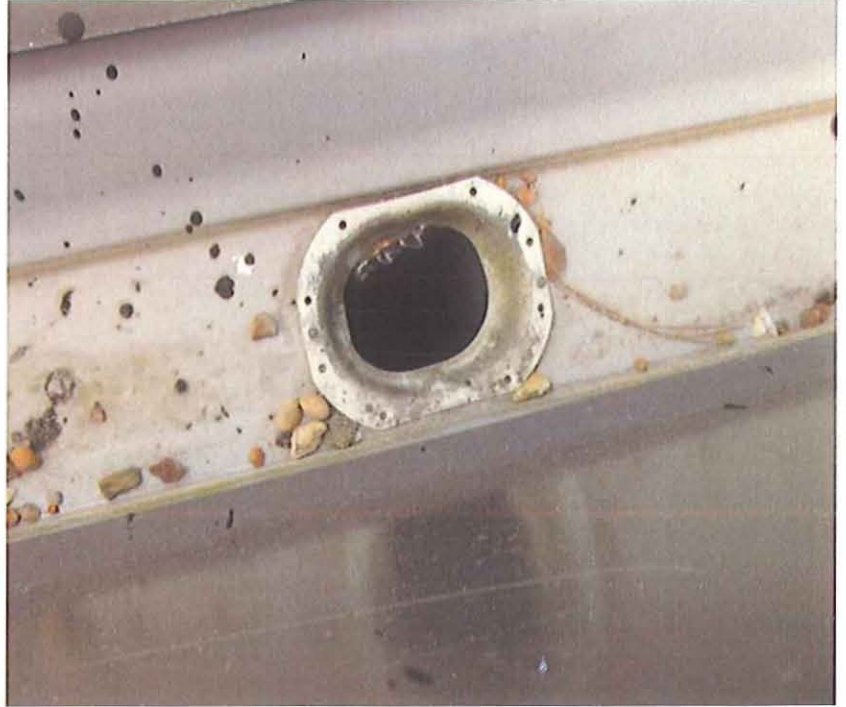
15. Deficiency #5 - Disconnected
downspout

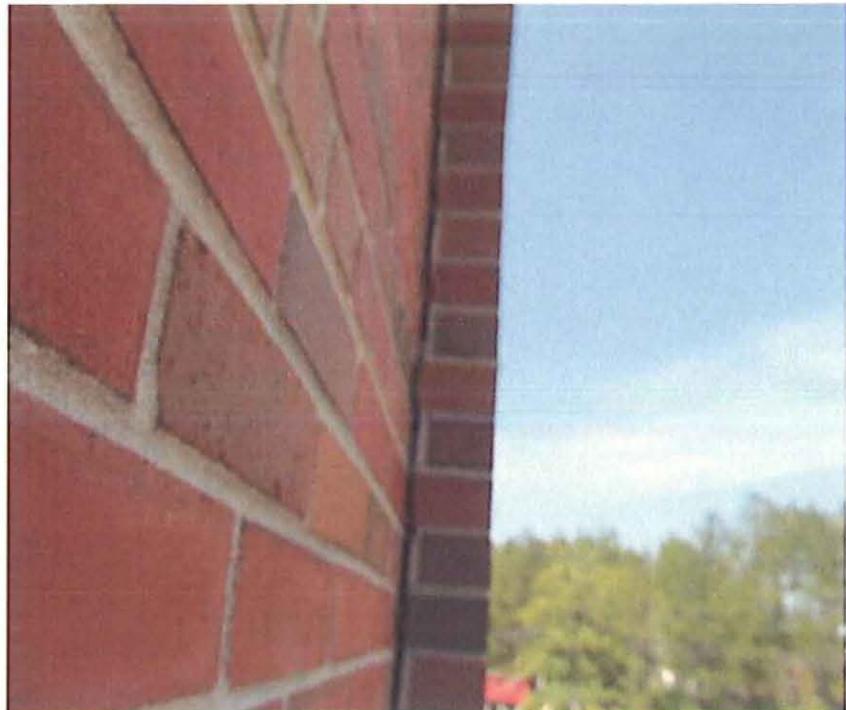
16. Deficiency #6 - Damaged /
broken masonry brick

6	MN	Damaged / broken masonry brick	1		
		Not a roof related issue - if area continues to deteriorate, contact qualified masonry contractor for repairs	Location		
7	M	Open / suspect gravel stop stripping	6	\$75.00	\$450.00
		Remove existing loose stripping material and install one ply of modified membrane stripping in compatible mastic or a five course application of roof cement and reinforced fiberglass fabric	Locations

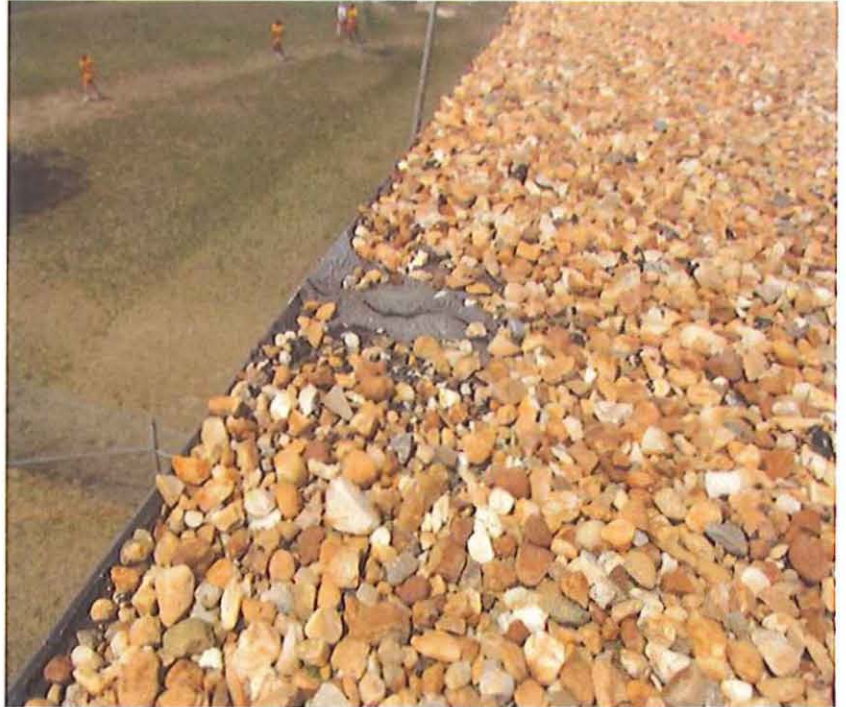
17. Deficiency #7 - Suspect gravel stop stripping

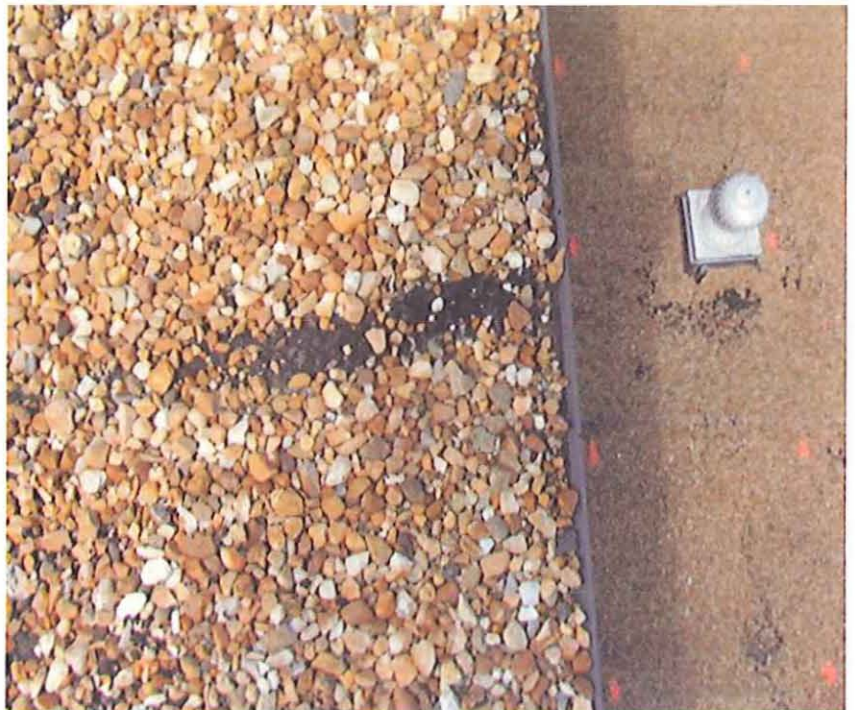
18. Deficiency #7 - Suspect gravel stop stripping

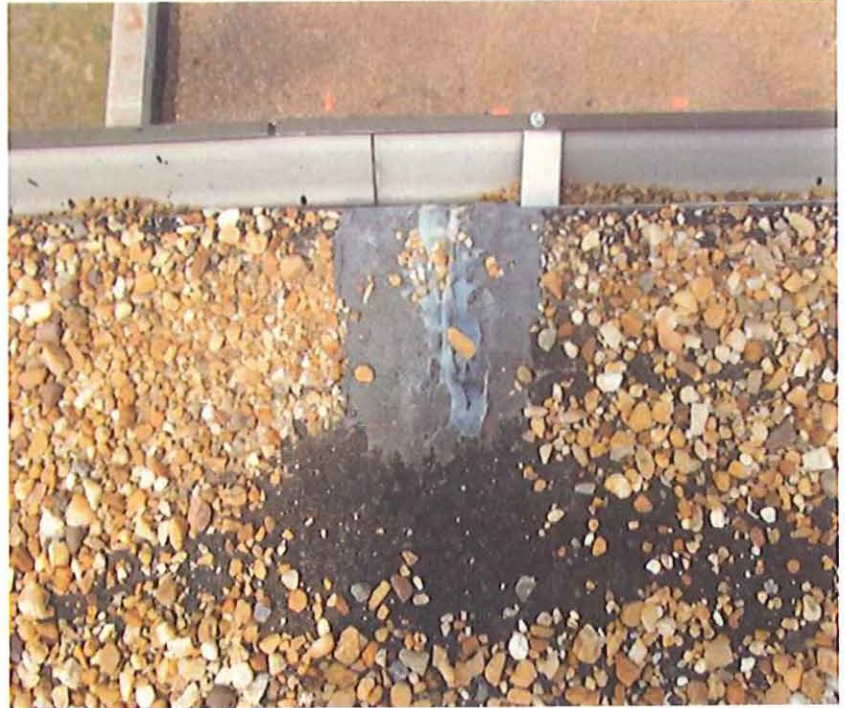
19. Deficiency #8 - Improper repair

NUMBER	PRIORITY CODE	DEFICIENCY DESCRIPTION	QUANTITY	UNIT PRICE	REPAIR COST
		DEFICIENCY SOLUTION	UNITS		
8	M	Improper repair	1	\$75.00	\$75.00
		Remove existing loose stripping material and install one ply of modified membrane stripping in compatible mastic or a five course application of roof cement and reinforced fiberglass fabric	Each		
9	M	Wet insulation	430	\$15.00	\$6,450.00
		Removed wet area, install compatible in fill roof insulation and compatible modified or built-up roof system	Sq Ft		
10	M	Lead collar open on stack pipe	1	\$50.00	\$50.00
		Install new lead cap that extends down over existing lead collar and turns down into pipe min of 1 inch	Each

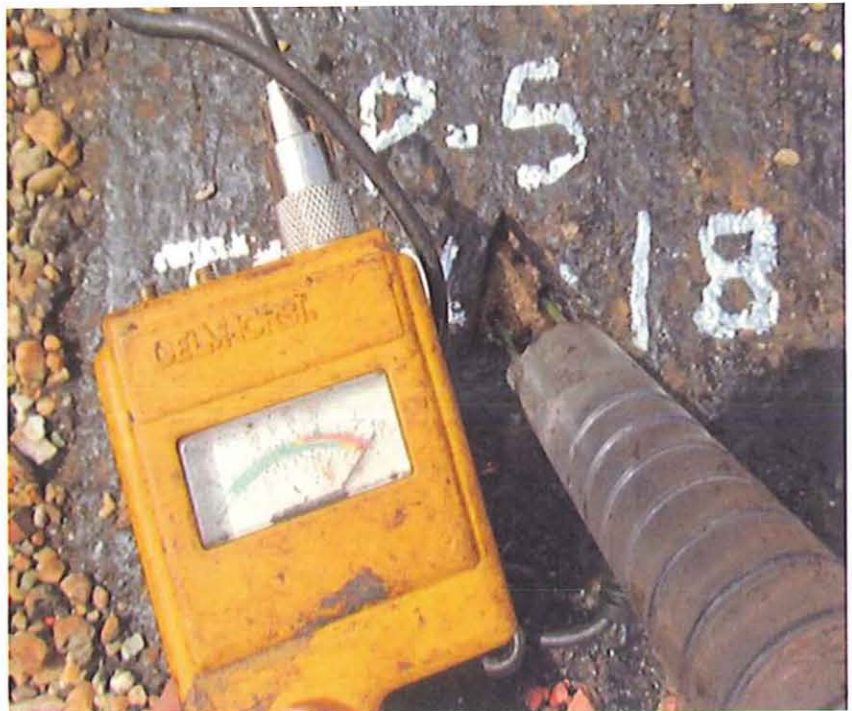
Based on the statistical analysis and roof core verification established for this project, it has been determined that approximately four hundred thirty (430) square feet of roof system was found detrimentally affected by moisture migration within the roof insulation. Of that area one hundred forty five (145) square feet is considered damp while two hundred eighty five (285) square feet is wet to saturated.

20. Deficiency #9 - Delmhorst meter reading insulation as saturated in probe

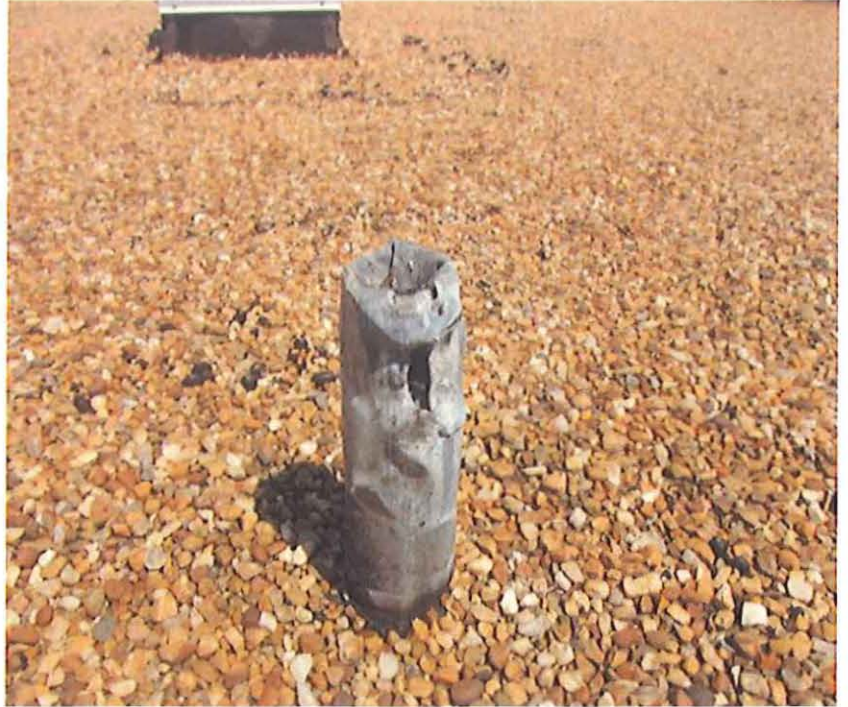
21. Deficiency #10 - Lead collar
open on stack pipe

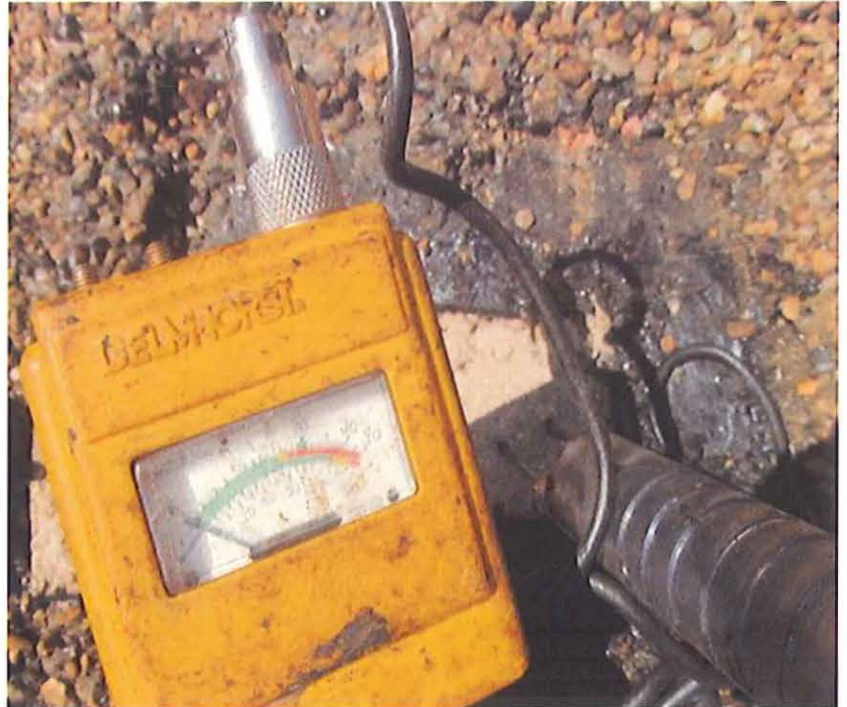
23. Test Cut #1 - Delmhorst meter
reading perlite as dry

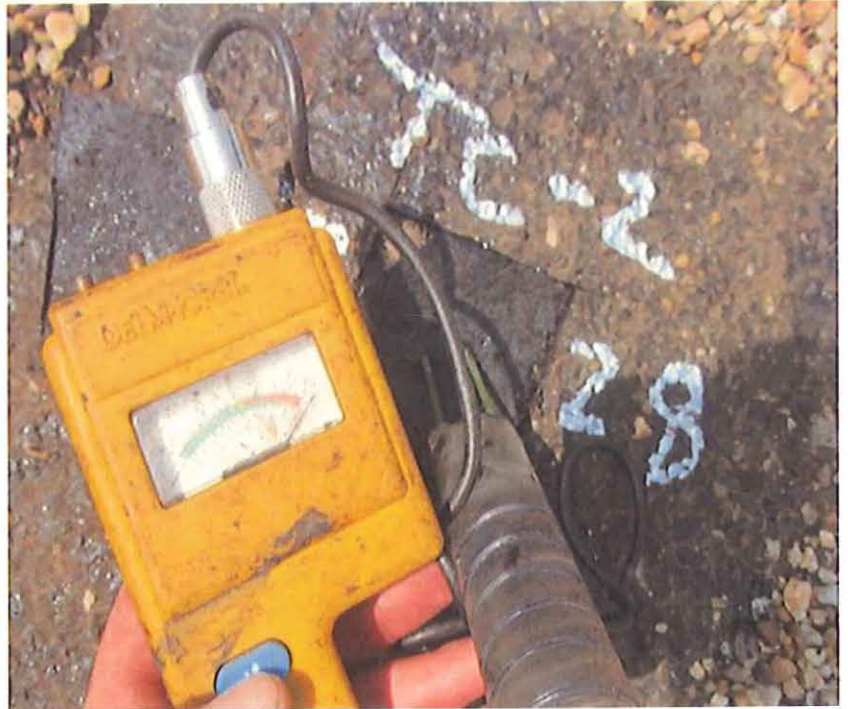
27. Test Cut #2 - Delmhorst meter reading perlite as saturated

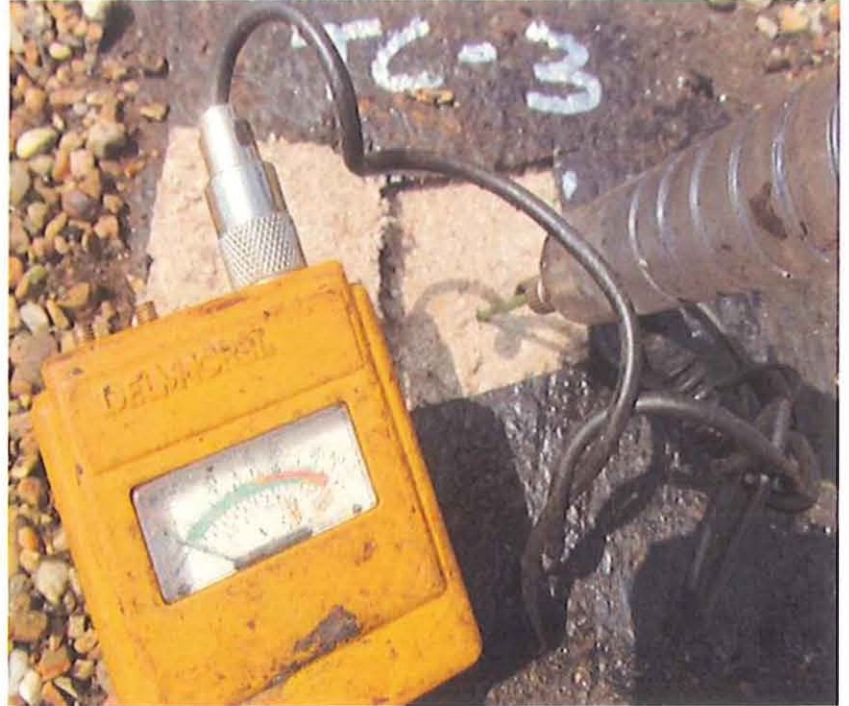
31. Test Cut #3 - Delmhorst meter
reading perlite as dry

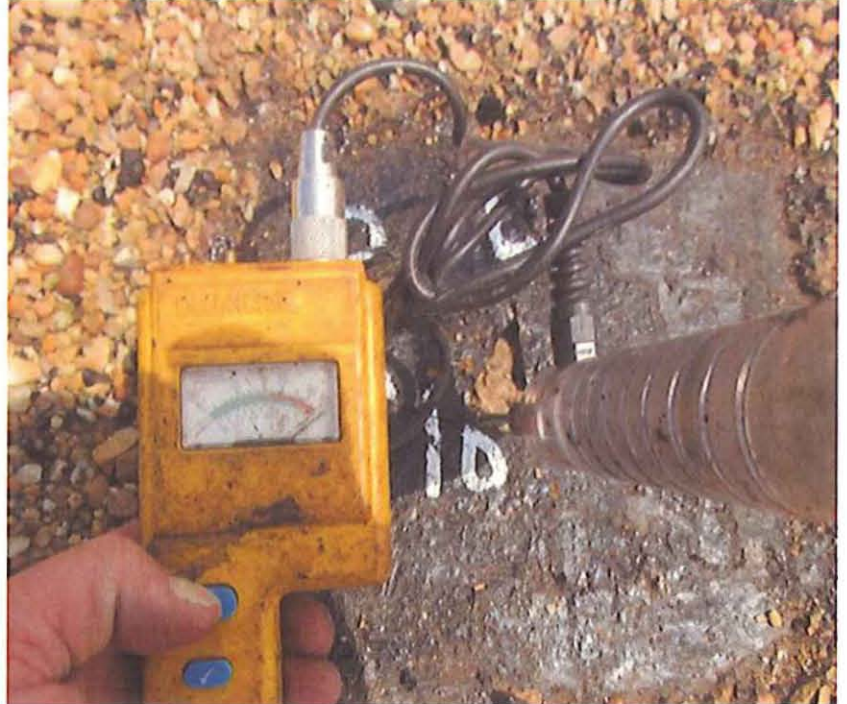
33. Probe #4 - Delmhorst meter reading insulation as saturated
