**Memorandum**

**SUBJECT:** Municipal Building - Roof and Exterior Repairs

**CURSORY VISUAL ASSESSMENT REPORT**

8 E Windsor Boulevard, Windsor, Virginia

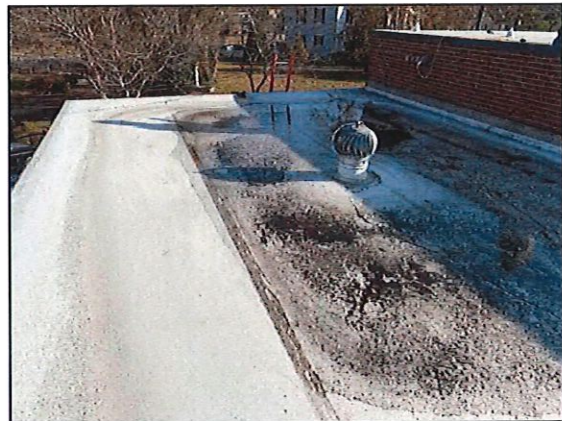
**Roof #1:**  
West Main Roof.  
Overview. Significant ponding water observed. Perimeter membrane is tenting and not secured along the perimeter.

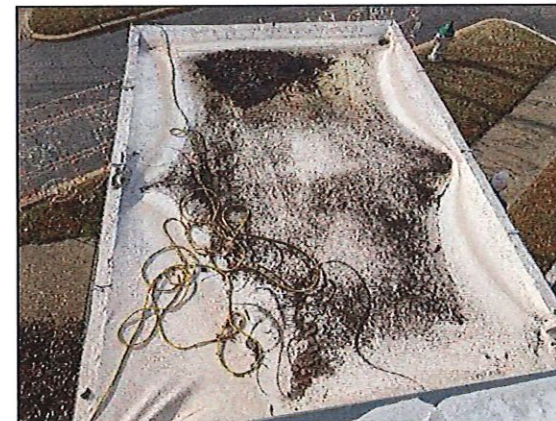
**Roof #4:**

West Canopy Roof

Overview. Significant ponding water observed. Perimeter membrane is tenting and not secured along the perimeter.

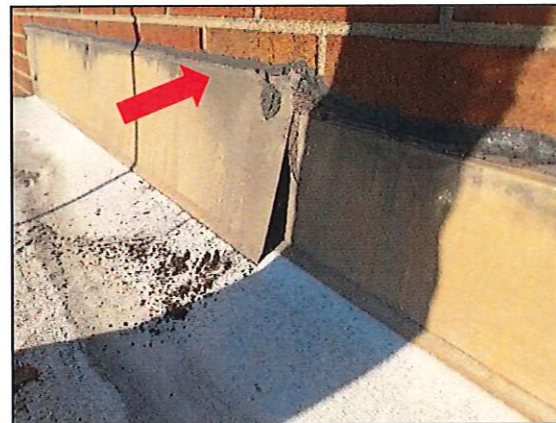
**Roof #6:**

The counterflashing installed over the roof membrane termination at the east and west rising walls to the middle roof is surface mounted to the brick masonry, allowing water within the brick masonry cavity to drain into the roof system or building interior.

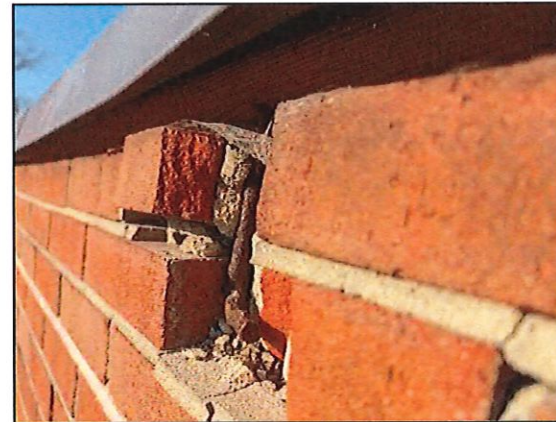
**Roof #7:**

The J-Hook attachment into the brick is damaged due to improper securement and excess tension in the membrane.

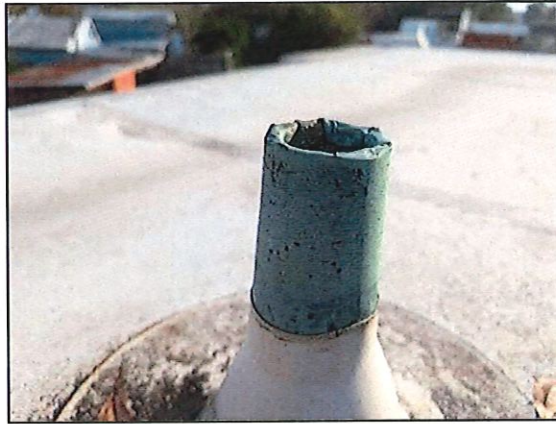
**Roof #8:**

Improperly flashed vent pipe penetration. The membrane should be sealed to the pipe penetration with water cut-off sealant and a hose clamp.

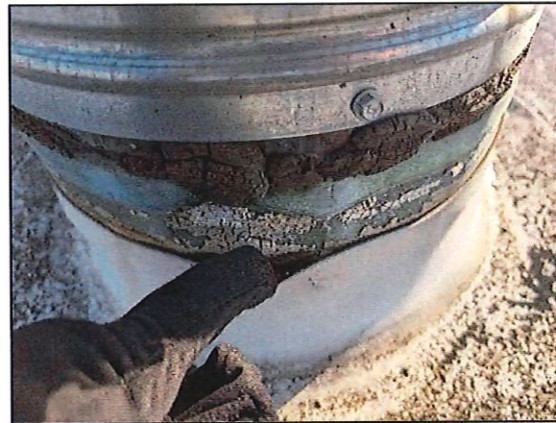
**Roof #9:**

Improperly flashed penetration. The membrane should be sealed to the pipe penetration with water cut-off sealant and a hose clamp.

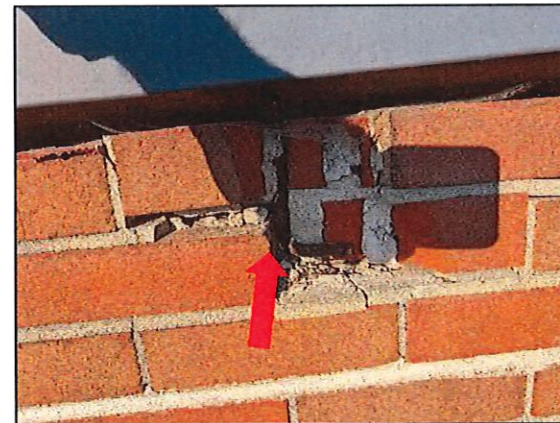
The roof perimeter wood nailer J-hooks have been pulled out of the brick masonry wall, causing damage to the brick masonry. Along the east elevation, the force pulling the wood nailer towards the center of the building has caused the masonry above the windows to deflect and damage the interior CMU. The steel lintels above wall openings are corroded and sealed to the masonry above. Typically, a through wall flashing is incorporated into the drainage system above windows, doors, and various changes in façade. The sealed lintels prohibit the through wall flashing from effectively draining water from the drainage cavity. The corrosion of the steel lintels has caused “rust jacking” where the masonry cracks and mortar joints separate due to the expansion of the metal. The separation of the mortar joints is not limited to around windows and was also observed throughout the facility exterior.

Typical damaged masonry at roof wood nailer attachment.

4. Install new through wall flashings at lintels.
5. Inspect the existing asphaltum wall moisture barrier for damage and repair as required.
6. Install new brick mixed in with existing brick to the roof edge. Securement of the roof wood nailer to the structural wall should be included in the roof design.

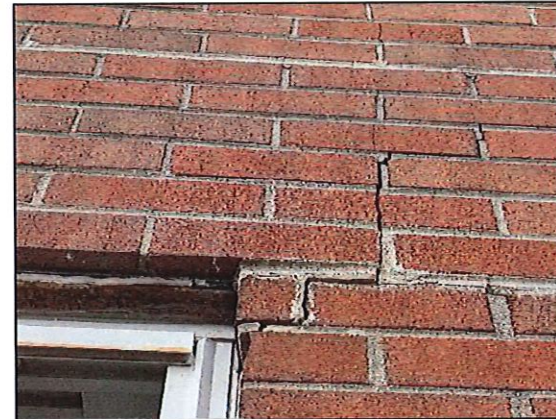
**Exterior #4:**  
Rust Jacking at steel lintels.

2. Remove the brick masonry above the windows to the roof edge along the east elevation of the facility. Store undamaged bricks for reuse.
3. Inspect steel lintels for severe corrosion, replace as required. Properly prepare and coat lintels to remain with rust inhibitive primer and paint.

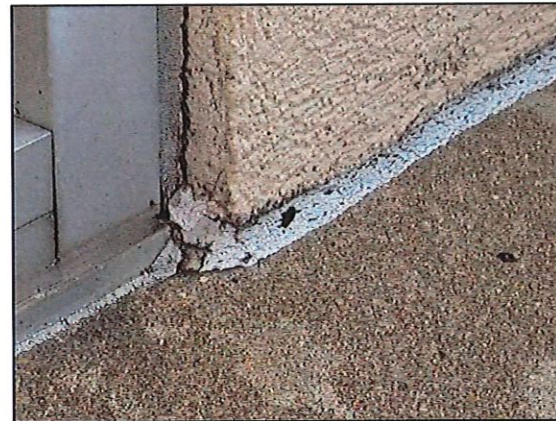
The EIFS façade is a barrier system. The waterproofing capabilities of the system rely on the integrity of the EIFS lamina and sealant joints to prevent water infiltration. The sealant joints around the perimeter of the EIFS at the transition to brick masonry and steel lintels is deteriorated, open, and may allow water into the system. The exterior lamina is compromised at multiple locations with various electrical conduits, lights, penetrations, and random screws fastened through the lamina, which may allow water to enter the system.

**Exterior #7:**  
Deteriorated Sealant at EIFS  
termination.

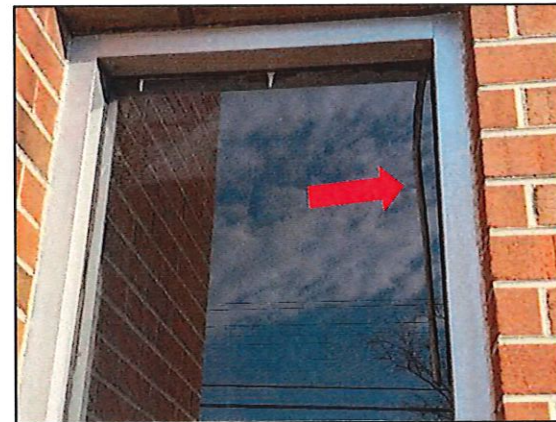
**Exterior #8:**  
Damaged vinyl gasket.

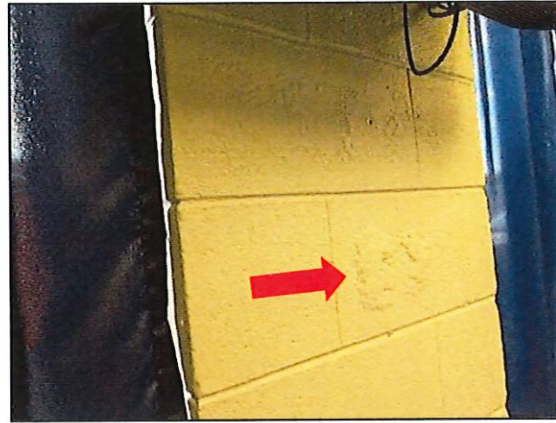
Brick masonry of this construction is designed with a drainage cavity to handle the intake of incidental moisture absorbed through mortar and the brick, while bulk water remains to the exterior of the facade. The damaged masonry, mortar joints, and sealed cavity drainage allow bulk water to enter the wall drainage cavity, which saturates the CMU, causing efflorescence on the interior CMU wall surfaces.

**Exterior #9:**  
Efflorescence on interior walls.

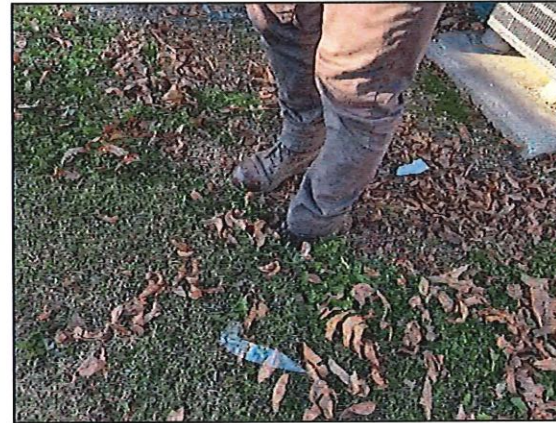
The roof downspouts connect to a below grade drainage system that extends along the north and east elevations and exits the property at the northeast corner of the building near the foundation. A storm drain is installed along the east elevation and is connected to the below grade drainage. The existing below grade drainage is terracotta piping and prone to damage. Two sink holes were observed along the drainage path, one at the northeast corner of the

building, and one by the storm drain. Sink holes along drain lines are typically an indication of damage piping, allowing water to erode the surrounding soil.

**Exterior #10:**  
Two sink holes were observed near the foundation of the facility.

1. Contract a geotechnical engineer to perform borings of the soil to confirm there are no settlement issues that may affect the structural integrity of the facility.

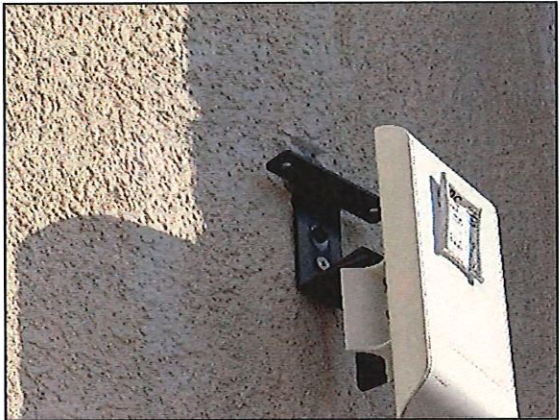
**Deficiency #2:**  
Equipment fastened through EIFS.

Recommendation: Remove the improperly fastened equipment and re-secure utilizing typical STO manufacturer's attachment details.

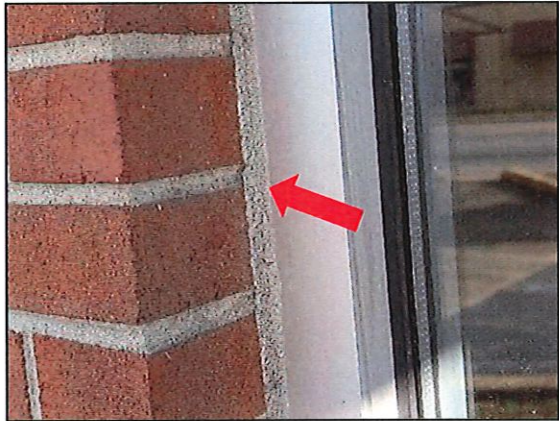
**Deficiency #3:**  
Deteriorated Sealant  
The sealant around the perimeters of the storefront windows, louvers, and other penetrations is deteriorated and separated.

Recommendation: Remove all sealants. Properly clean and prepare the substrates. Install a new properly detailed continuous sealant joint and backer rod.

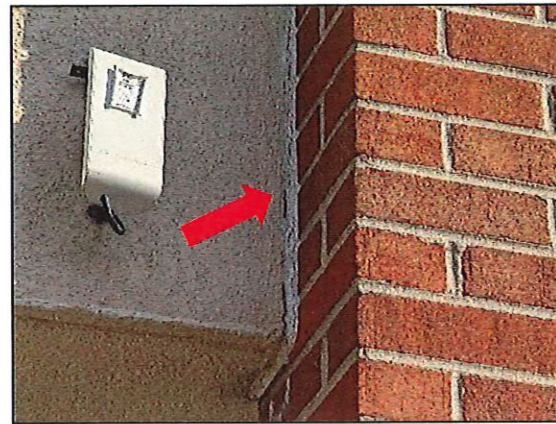
**Deficiency #4:****Deteriorated Sealant**

The sealant at the transition of the EIFS infill and various substrates is deteriorated.

Recommendation: Remove all sealants. Properly clean and prepare the substrates. Install a new properly detailed continuous sealant joint and backer rod from the EIFS base coat to adjacent substrate.

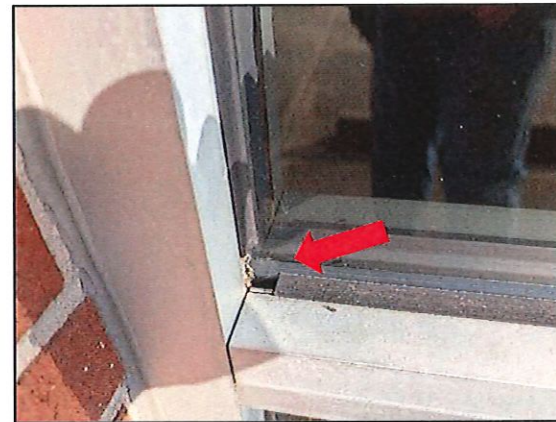
**Deficiency #5:****Damaged Vinyl Gasket.**

The vinyl gaskets of the storefront system have shrunk, leaving voids in corners.

Recommendation: Replace all storefront vinyl gaskets with properly sized gasket and sealant as required.

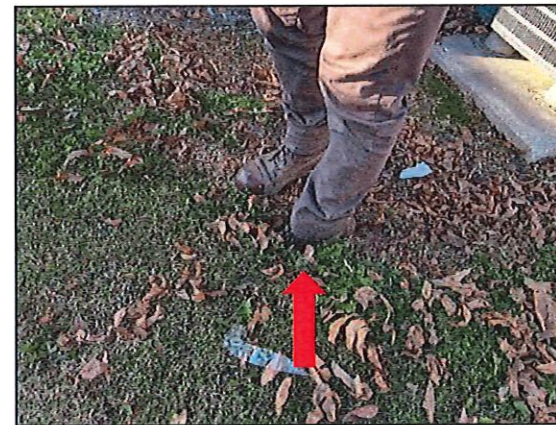
**Deficiency #6:**

Two sink holes were observed near the foundation of the facility. One on the northeast corner, and one along the east elevation.

Recommendation: Scope the underground piping for damage. Replacement of the drainage pipe may be required. Contact a geotechnical engineer to perform borings to investigate the stability of the soil around the building foundation.

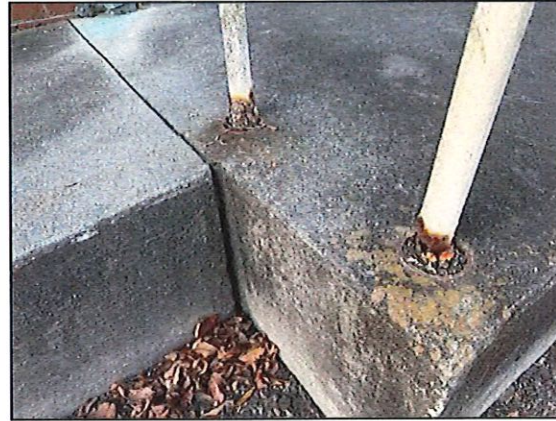
**Deficiency #7:**

The steel railing of the concrete ramp on the north elevation deteriorated and separated from the foundation.

Recommendation: Replace the railing with a new railing. Confirm ADA requirements prior to replacement. Repair details may be created upon request.

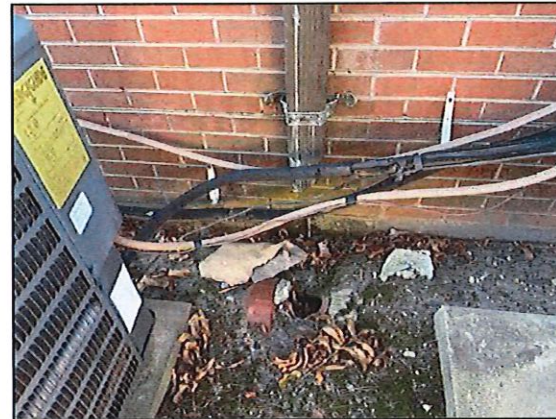
**Deficiency #8:**

A roof downspout was not connected to the below grade drainage pipe.

Recommendation: Reconnect the downspout to below grade drainage to prevent water from building up along the foundation.

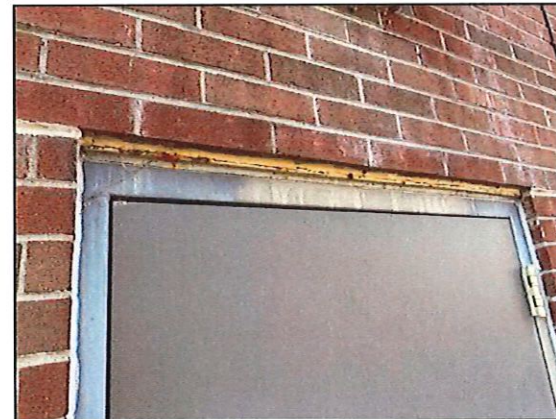
**Deficiency #9:**

The steel lintels above wall openings is corroded, causing rust jacking, and sealed to the masonry above.

Recommendation: Remove the sealant from the lintel to the masonry. Remove masonry to expose the lintel. Inspect steel lintels for severe corrosion, replace as required. Properly prepare and coat lintels to remain with rust inhibitive primer and paint. Install new properly detailed through wall flashing above lintels.
